Service Bulletin

Bulletin No.: 16-NA-394

Subject: Poor A/C Performance

Brand:	Model:	Model Year:		VIN:		Engine:	Transmission:
		from	to	from	to		
Buick	LaCrosse	2017	2018			LFV, LGX, LKN, LTG	
Chevrolet	Malibu

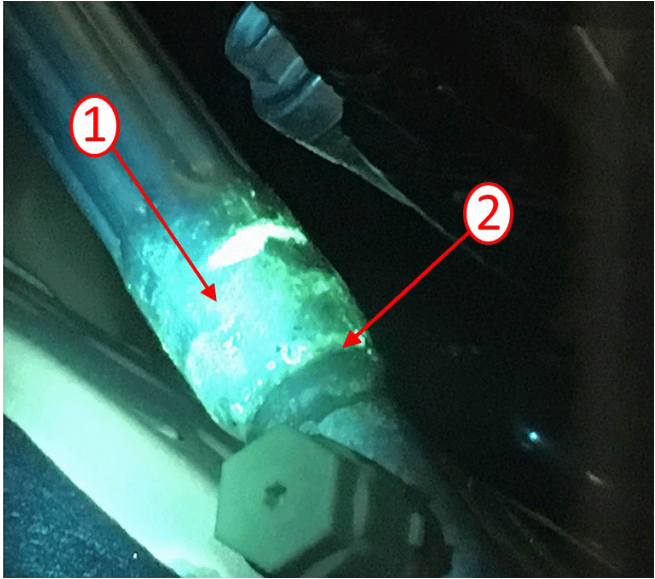
<p style="text-align: right; font-size: small;">4598662</p> <p>This condition may be caused by a refrigerant leak (1) at the weld (2) on the A/C heat exchanger line or compressor hose.</p>

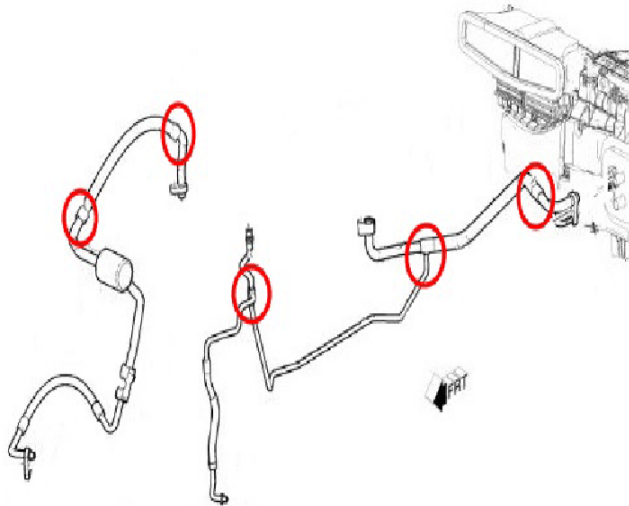
4601649

After performing normal SI diagnostics, if the source of the leak is not found, refer to the graphic above to check the A/C heat exchanger and compressor hose for air conditioning system dye at all the indicated welds using an ultraviolet (UV) light.

If dye has been validated at the line weld, **replace only the A/C line that show signs of the leak.**

Replace the A/C heat exchanger line. Refer to *Air Conditioning Refrigerant Heat Exchanger Replacement* in SI.

Replace the A/C compressor hose. Refer to *Air Conditioning Compressor Hose Replacement* in SI.
