Subject: Engineering Information – BOTH Front Low Beam, High Beam, Day Time Running Lamps (DRL) and Turn Signals Inoperative

Brand:	Model:	Model Year:		VIN:		Engine:	Transmission:
		from	to	from	to		
GMC	Sierra	2016	2018			All	All

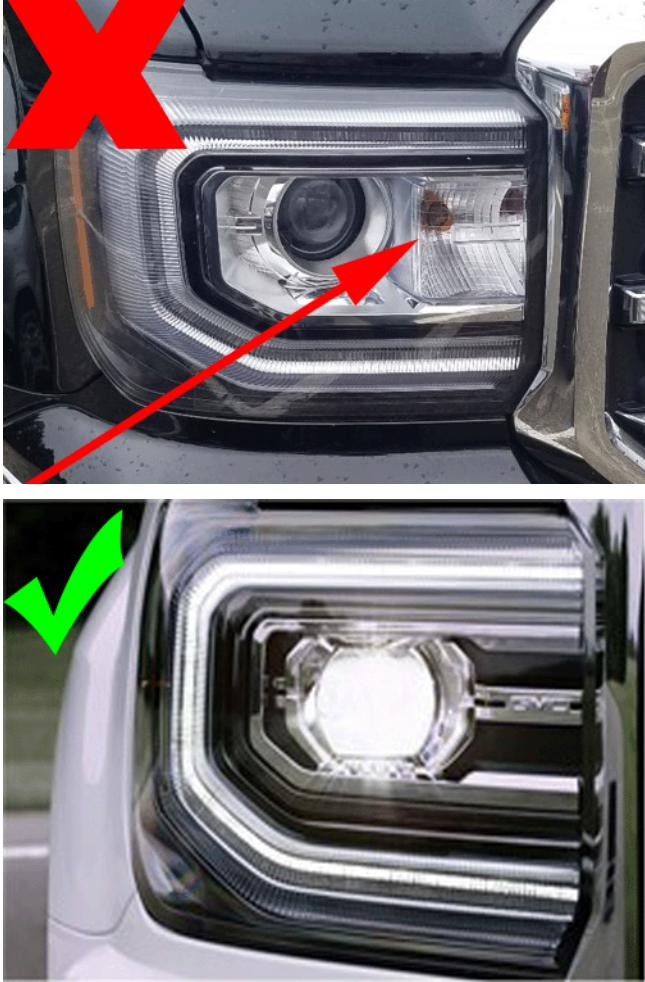
<p>Some customers may comment that the front right hand AND left hand low beam, high beam, DRL, and turn signals are inoperative but the side markers still work as intended. If the turn signals are used, a turn signal bulb out message will be displayed.</p>
<p>Cause</p>	<p>GM Engineering is attempting to determine the root cause of the above condition. Engineering has a need to gather information on vehicles PRIOR to repair that may exhibit this condition. As a result, this information will be used to "root cause" the customer's concern and develop/validate a field fix.</p>
