# Service Bulletin

Bulletin No.: 17-NA-333

**Subject: Power Tilt and Telescope Switch Pushes into Steering Column**

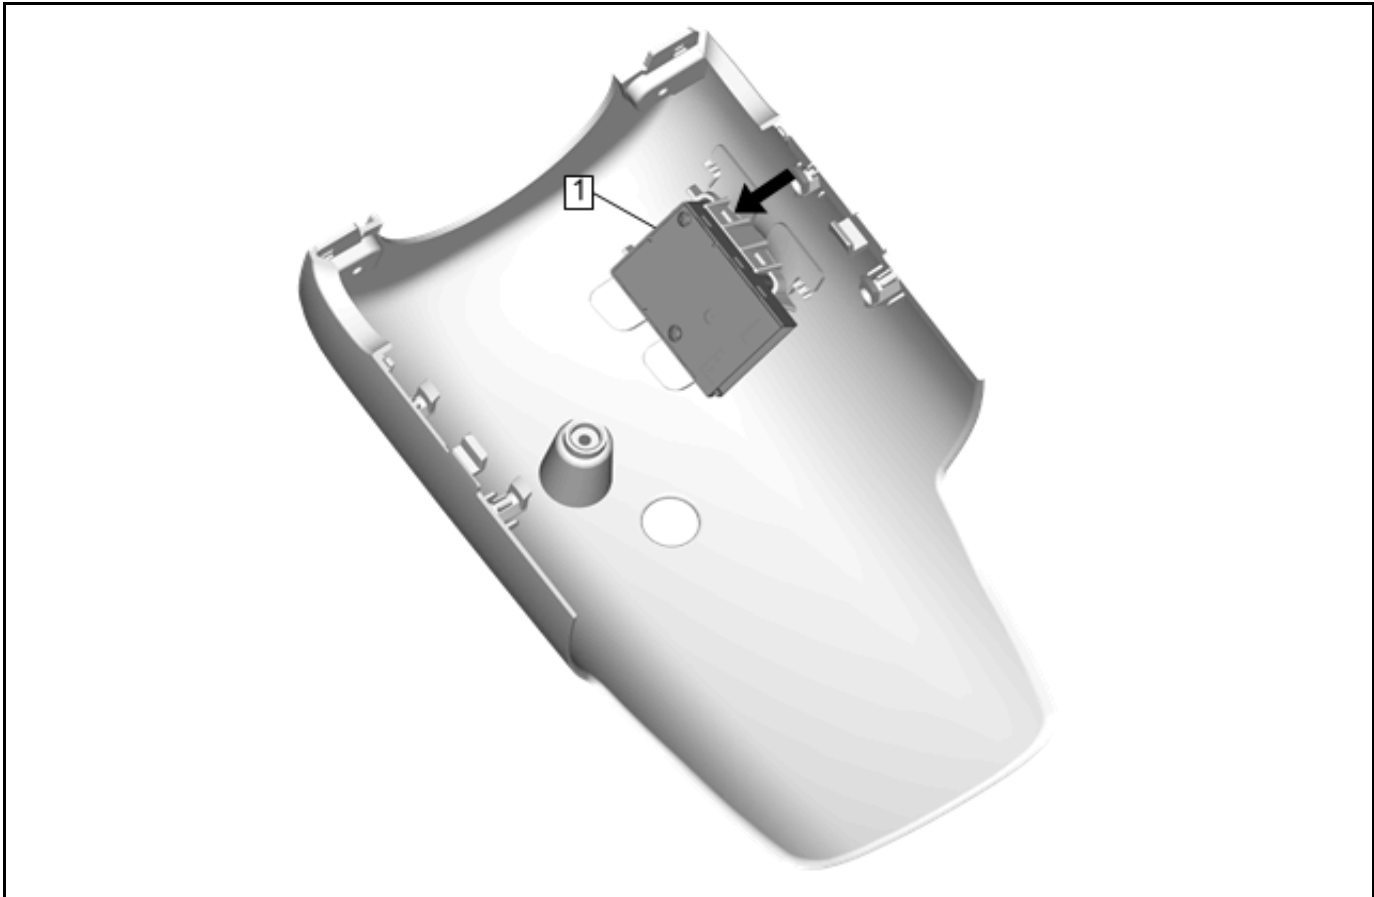
4284151

<b>Involved Region or Country</b>	North America, South America, Middle East, North Africa and Russia.
<b>Condition</b>	Some customers may comment that the Power Tilt and Telescope Column switch can be or has pushed into the lower column cover.
<b>Cause</b>	This may be due to the lower steering column cover switch retention features do not apply enough force on the side of the switch to retain the switch if pressed hard or bumped by a knee.
<b>Correction</b>	Apply butyl tape around sides of switch pocket to hold the retention clips against the switch using the procedure outlined below.

3. Apply butyl tape around sides of switch pocket to hold the retention clips against the switch.
