## **Service Bulletin**

Bulletin No.: 17-NA-335

Subject: Malfunction Indicator Lamp Illuminated (MIL) - DTC P2635 and/or P018B Set In High Ambient Temperatures With Hesitation, Surging and Stalling

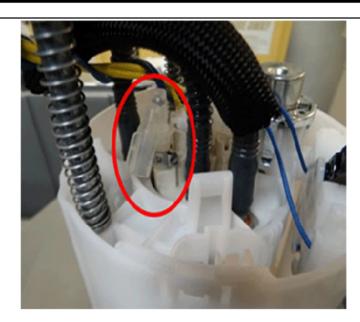
4882977

Involved Region or Country	North America and N. A. Export	
Condition	Some customers may comment that the Malfunction Indicator Light (MIL) is illuminated.  Some customers may also comment on one or more of the following symptoms:  • Hesitation  • Surging  • Stalling  Note: In ambient temperatures 100 F (37.7 C) degrees or higher, DTCs P2635 and/or P018B may set.	
	The Technician may find one or more of the following DTCs set: P2635 P018B	
Cause	This condition may be caused by a vapor buildup in fuel feed line.

If the conditions stated above are met, replace the fuel pump module with an updated version.
