Service Bulletin

Bulletin No.: 17-NA-336

Subject: Rear Fascia Gap

| Brand: | Model: | Model Year: | | VIN: | | Engine: | Transmission: |
|---|---|---|---|---|---|---|---|
| Chevrolet | Camaro | 2017 | 2018 | | | All | All |

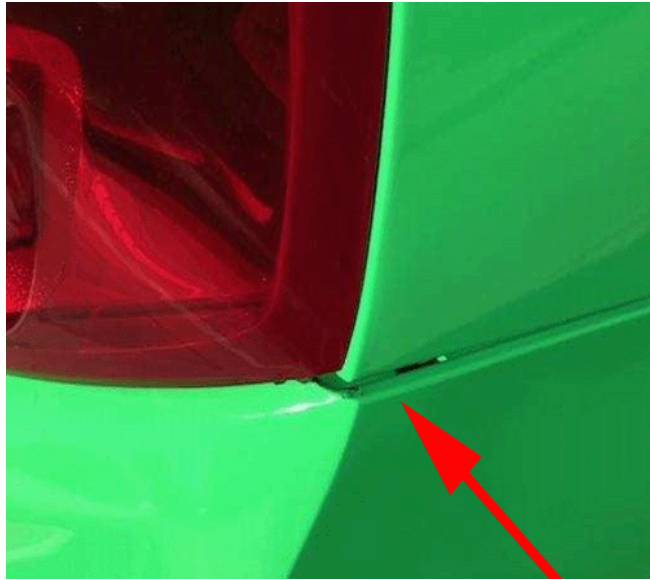
| Involved Region or Country | North America, China, Korea, Europe, Russia and N.A. Export Regions |
|---|--|
| Condition | 4882654 |

Some customers may comment that the rear fascia is sticking out near the tail lamp.

| Cause | This may be due to the stud not being centered in the hole of the impact beam mounting plate. |

| Correction | Loosen nuts to the impact beam and re-adjust using the procedure outlined below. |
