## Waistline trim strips on doors protrude at front or rear of waistline

| Topic number | LI72.00-P-067456 |
| Validity | MODEL 213<br>Up to production date 13.01.2017 |

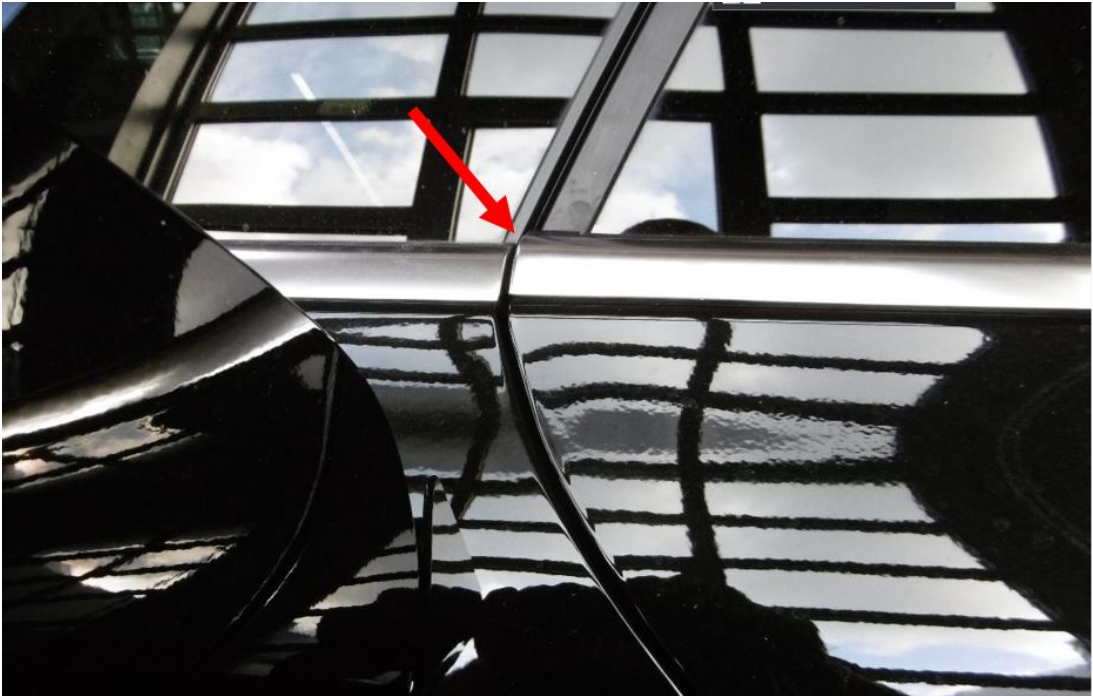
Bild 1.JPG:

Waistline trim strips on doors protrude at front or rear of waistline, see picture 1.

The holding ability of the insertion slot may be insufficient.
