# Customer Satisfaction Program

## 17206 Radio Module Software Update

**Reference Number:** N172098380

**Revision:** 02

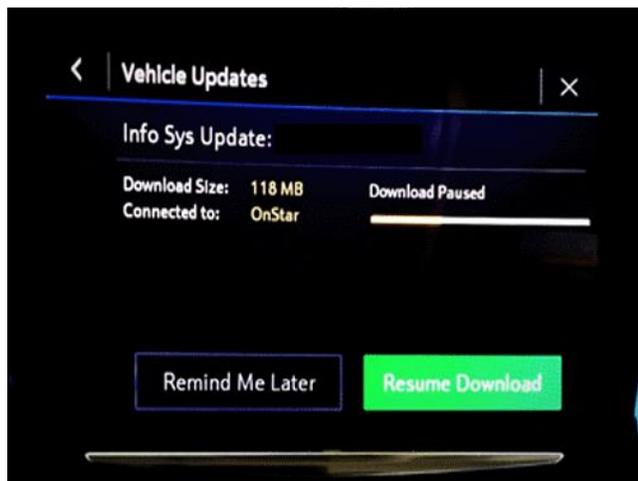
4880803

- From the radio home screen, select “Settings” then “Vehicle Software”. Under “About”, locate the Build Number. If the build number is anything other than 19.2, proceed with software update.

**Caution:** If Vehicle Update screen shows “Info Sys Update”, do not use TIS2WEB or insert a USB stick. Use of the USB stick when the Remote Update has already been downloaded, installed, or paused during installation could result in program failures or module lockup condition. The update should be completed using the Remote Vehicle Update procedure, following prompts on the infotainment screen. Refer to *Update Procedure Using Remote Vehicle Update* after reading the remaining information in this section if the Remote Update has already been downloaded to the radio.

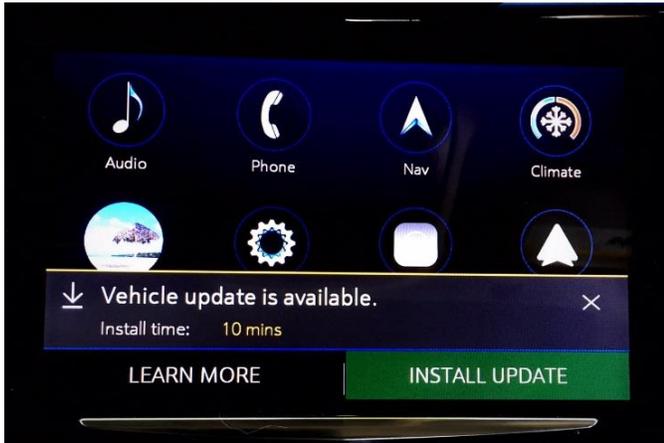
4880808

1. Start the vehicle to determine if the update has been downloaded to the radio. The vehicle must be running for the update screen to be shown.
  - If the radio has downloaded the remote vehicle update and the radio is ready to be updated, the screen above will be shown when the vehicle transitions to park. Select Install Update and follow on the on-screen prompts.

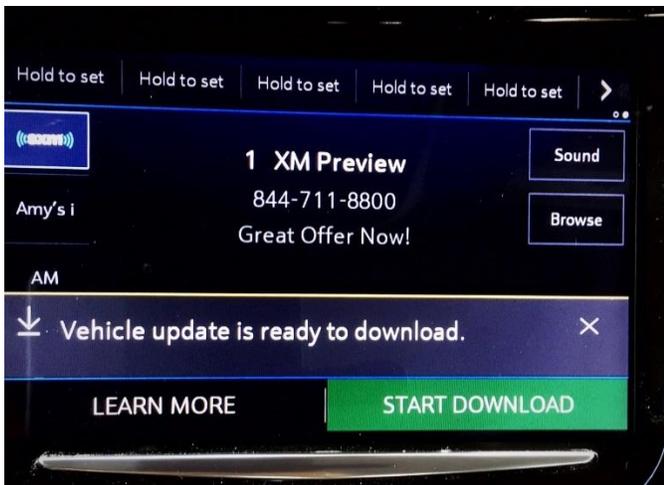
4880809

- If the remote vehicle update has not been downloaded, select "Start Download" as shown above.

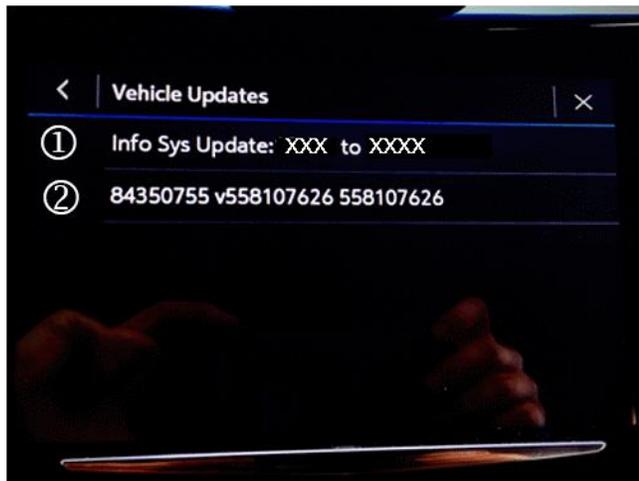
4880825

6. If a Remote Vehicle Update exists on the vehicle and has not been declined, the screen above will be displayed. Select the “Info Sys Update” option and follow steps 1.1 and 1.2 to decline the update before continuing with the USB update.
7. Once the Remote Vehicle Update has been declined, select the USB file (2) to continue programming the SPS update.

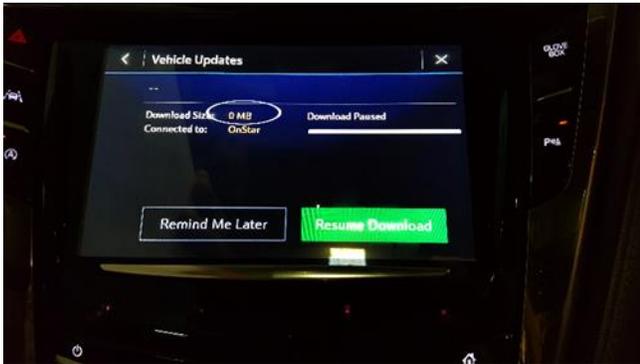
4882429

If a USB was installed during a paused Remote Vehicle Update download, the paused update screen will have a blank update title and a 0 MB file size.

- Turn the vehicle off, and remove the USB device from the vehicle.
- Contact the Techline Customer Support Center (TCSC) at 1-800-828-6860 (1-800-503-3222 French) for assistance.

If the Vehicle Updates screen shows a blank update title, follow steps 1 and 2 of the “Update Procedure Using SPS” to decline the package and then proceed with USB programming.

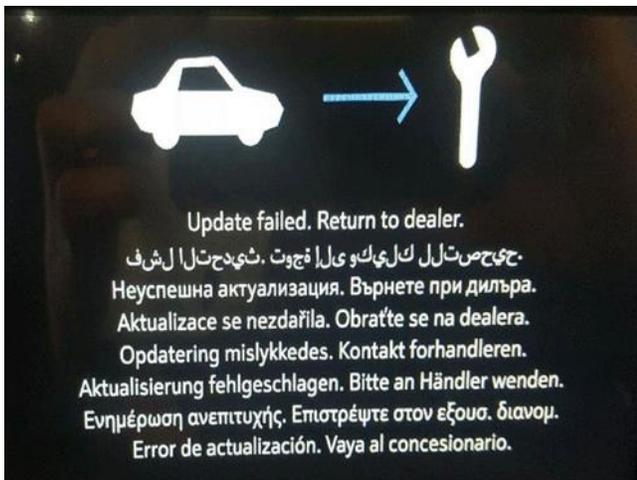
4892444

If this screen above is shown when trying to update the radio through USB, use a different USB drive, format to FAT32 and try to download the update through TIS2WEB again. If the screen above is shown again, contact the Techline Customer Support Center (TCSC) at 1-800-828-6860 (1-800-503-3222 French) for assistance.

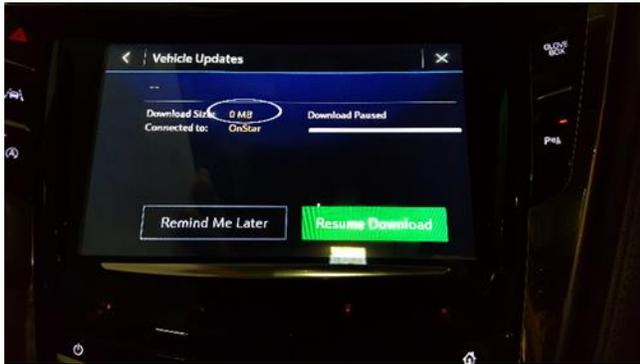
4882429

- After programming via Update Procedure through SPS navigate to Vehicle Settings – Updates. A screen will be displayed that an update is available to continue downloading. The paused update screen will have a blank update title and a 0 MB file size.
- Contact the Techline Customer Support Center (TCSC) at 1-800-828-6860 (1-800-503-3222 French) for assistance.
