# Customer Satisfaction Program

## 17328 Radio Module Software Update

**Reference Number:** N172117760

**Release Date:** November 2017

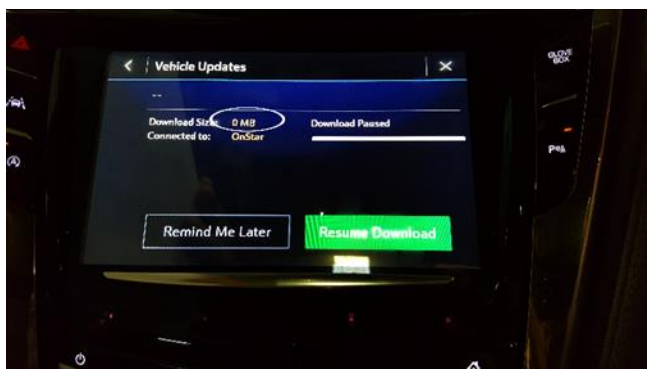
4882429

If a USB was installed during a paused Remote Vehicle Update download, the paused update screen will have a blank update title and a 0 MB file size.

- Turn the vehicle off, and remove the USB device from the vehicle.
- Contact the Techline Customer Support Center (TCSC) at 1-800-828-6860 (1-800-503-3222 French) for assistance.

If the Vehicle Updates screen shows a blank update title, follow steps 1 and 2 of the “Update Procedure Using SPS” to decline the package and then proceed with USB programming.

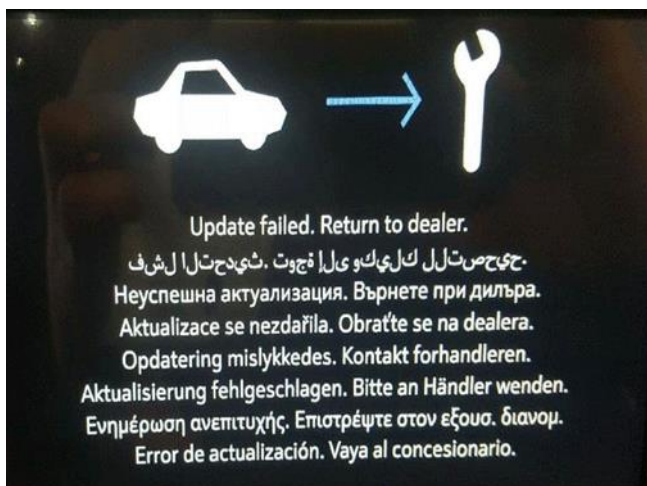
4892444

If this screen above is shown when trying to update the radio through USB, use a different USB drive, format to FAT32 and try to download the update through TIS2WEB again. If the screen above is shown again, contact the Techline Customer Support Center (TCSC) at 1-800-828-6860 (1-800-503-3222 French) for assistance.

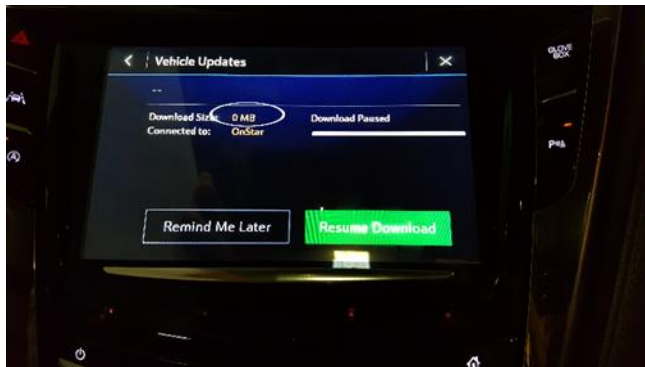
4882429

- After programming via Update Procedure through SPS navigate to Vehicle Settings – Updates. A screen will be displayed that an update is available to continue downloading. The paused update screen will have a blank update title and a 0 MB file size.
- Contact the Techline Customer Support Center (TCSC) at 1-800-828-6860 (1-800-503-3222 French) for assistance.
