# Service Update

## 17415 Intermediate and Pinion Steering Shaft Corrosion

Reference Number: N172107650

Release Date: November 2017

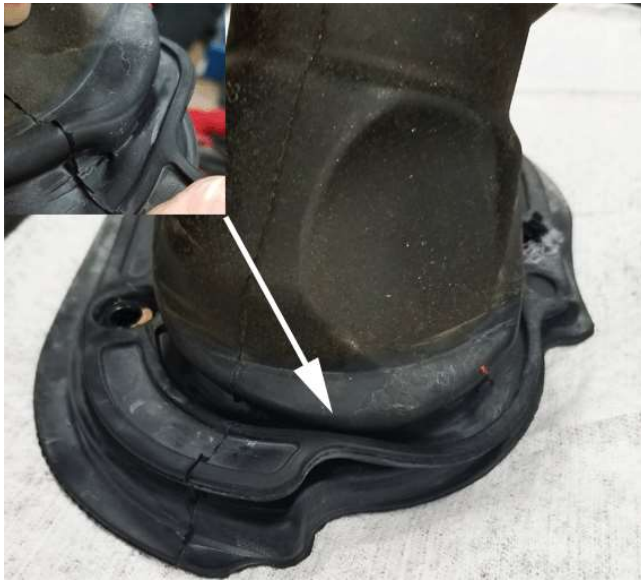
4900311

- If the top of the boot appears to be pinched and is fused to itself, as shown above, replace inner steering shaft boot seal. Do NOT replace a boot that does not exhibit this condition.
