Water deflector/ seal lip tears

Topic number	LI77.50-P-065522
Version	1
Design group	77.50 Hardtop
Date	01-11-2017
Validity	BR190 Coupe
Reason for change	
Reason for block

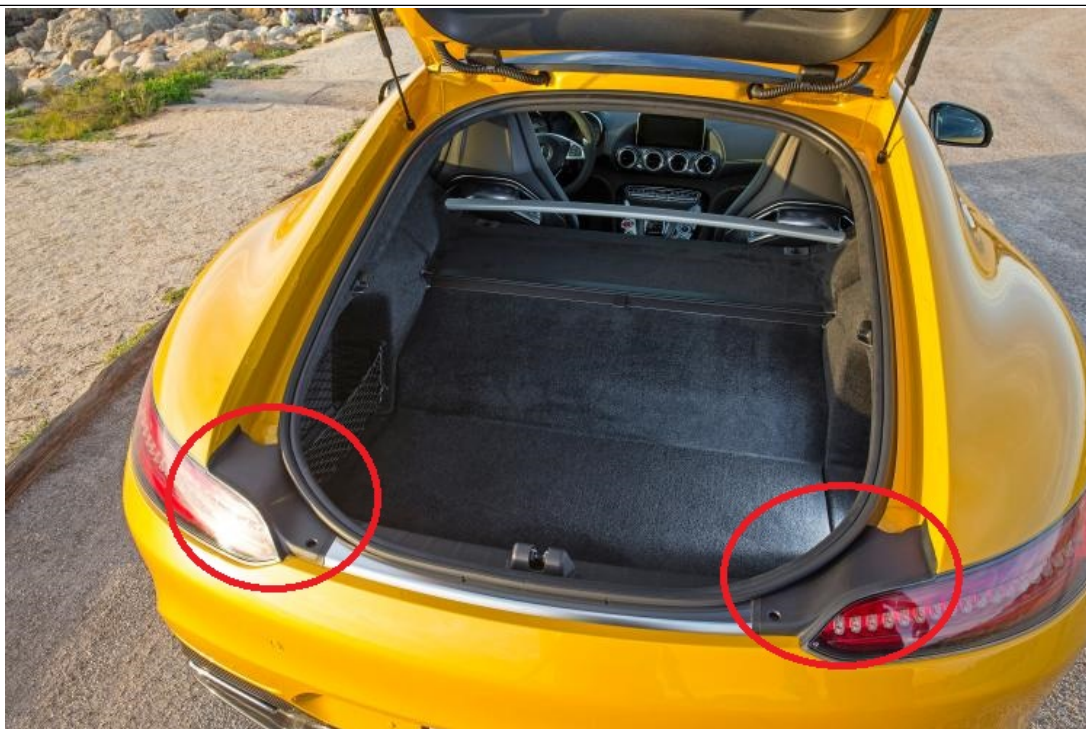
GTS trim.JPG:

Water deflector/ seal lip tears

Attachments	
File	Description
GTS trim.JPG	location

Bond between rubber and plastic

Replacement of affected water deflector/ seal lip using part numbers below
