## Noise on left/right door power window when moving up/down

| Topic number | LI72.10-P-065523 |
| Design group | 72.10 Front door |

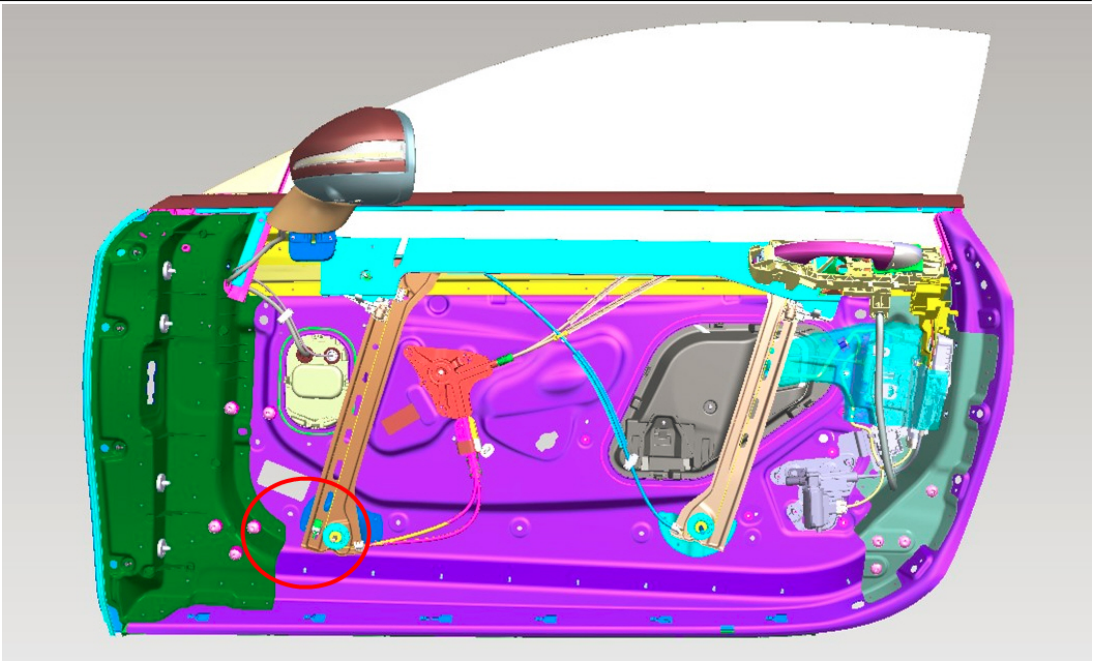
Bild 1.JPG:

Geometric deviation of side window pane in area of window opener mounting.

This means that when the window is in a lowered position, interference may occur with the side window pane and the wiring harness protection for the door wiring harness.

1. Remove outer sealing rail for window.
2. Lower side window pane
3. Perform visual inspection to see if side window pane interferes with door wiring harness protection.
4. If interference occurs, adjust wiring harness out of the way and replace side window pane if necessary.
