Noises and lateral play at cushion frame or at seat adjuster

Topic number	LI91.10-P-059365
Version	2
Design group	91.10 Front seats
Date	01-10-2017
Validity	169 (up to # 148889), 245 (up to # 005018)
Reason for change	Damage code deleted
Reason for block

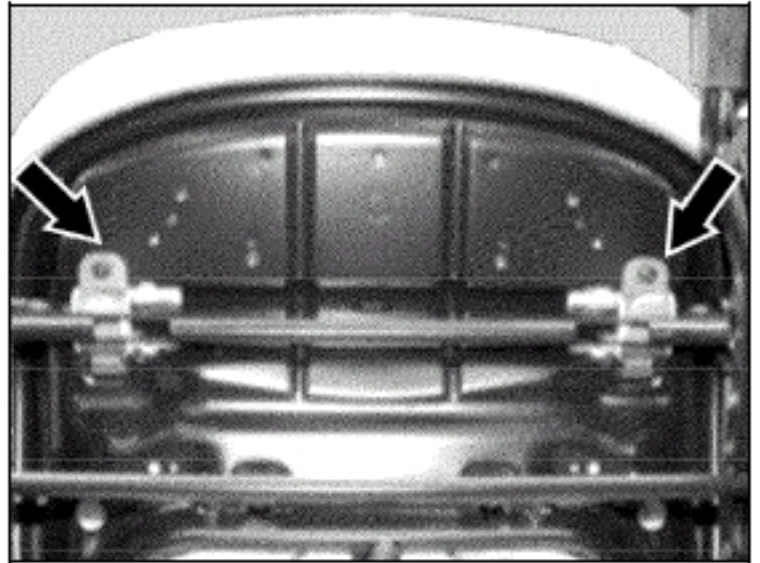
PIC_1.jpg:

The front bearing shells of the seat cushion shell (PIC_1) allow the seat cushion a certain amount of play.

The cracking noise occurs between the plastic bearing and the cross-connection pipe.

Important: The front seat cushion bearings must be accessible (PIC_1)
