## Memory function of electric seat adjustment faulty

| Topic number | LI91.10-P-059373 |
| Design group | 91.10 Front seats |
| Validity | Model series 211, vehicles with electric seat adjustment<br>USA as of VIN end number 554000 (production date as of 19.03.2004)<br>Rest of world as of VIN end number 610907 (production date as of 01.06.2004) |

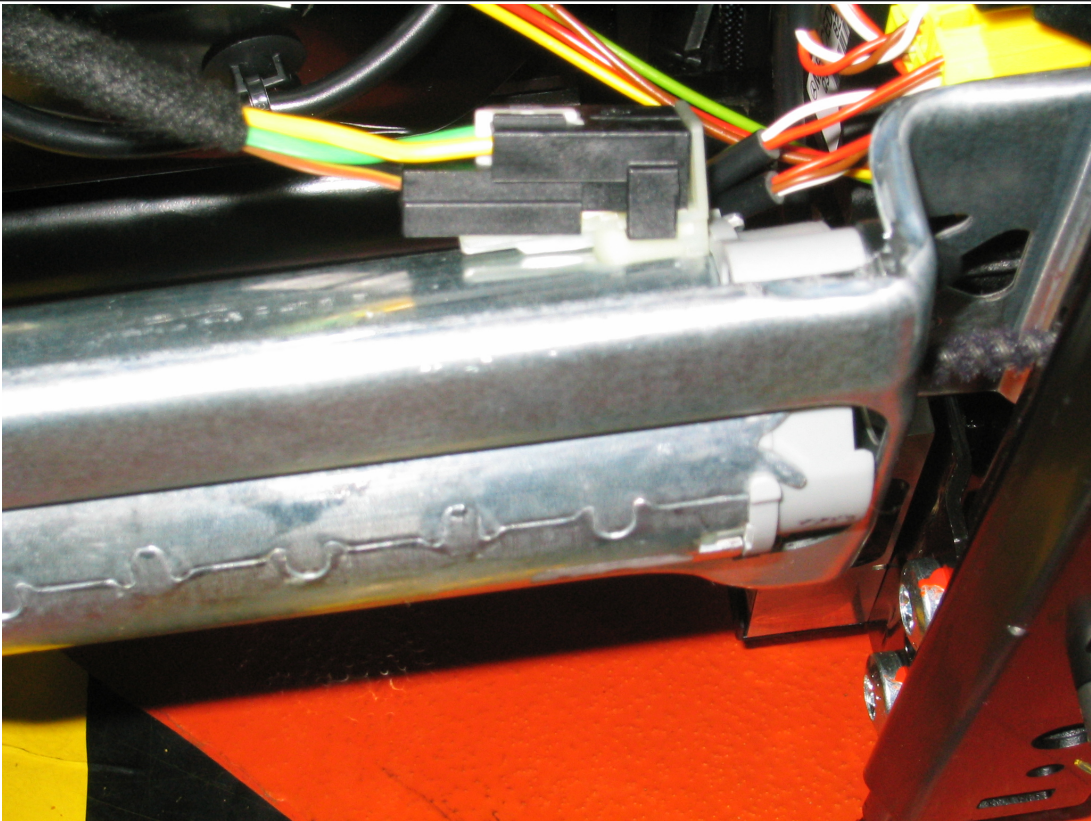
Stecker Motor niO.jpg:

Contacts on seat fore/aft adjustment motor incorrectly connected.

This leads to a fault in the Hall sensor and may cause the normalization settings of the seat fore/aft adjustment to be lost.

| Attachments | |
|---|---|
| Stecker Motor niO.jpg | Fault symptoms for plug incorrectly engaged |

Connect plug X55/3 on seat fore/aft adjustment motor correctly.

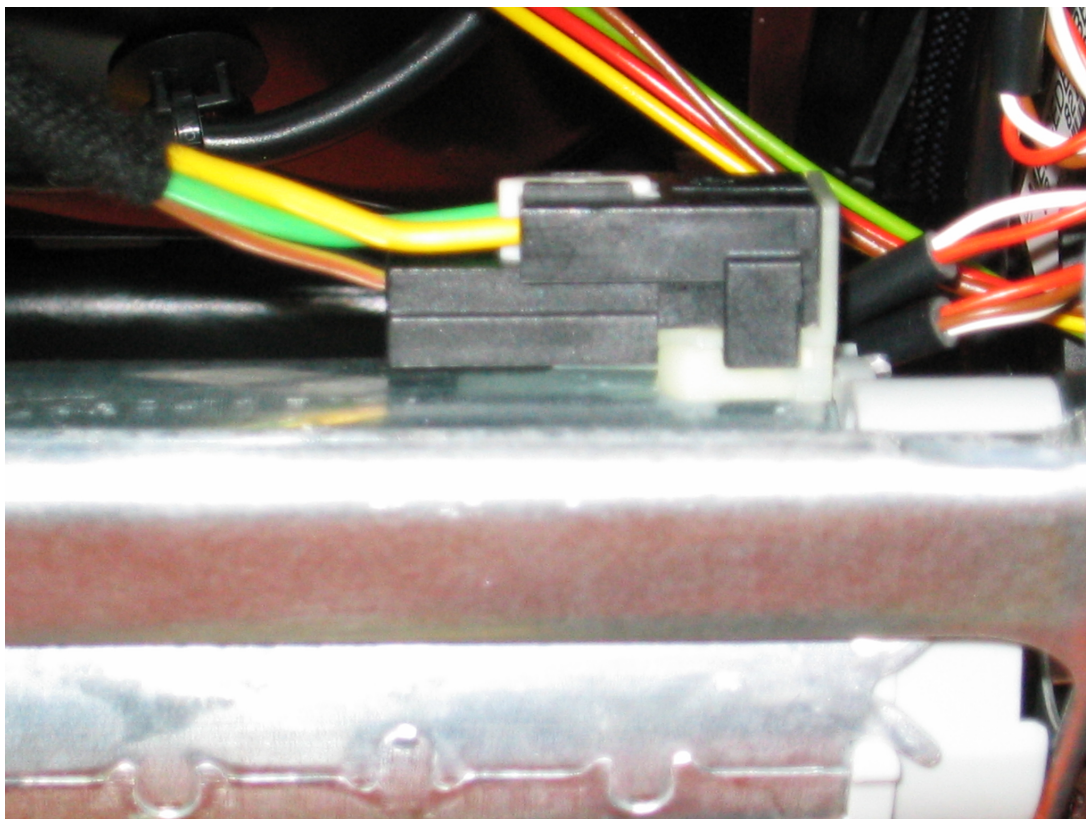
Stecker Motor iO.jpg:

| Attachments | |
|---|---|
| Stecker Motor iO.jpg | Plug correctly engaged |
