## Creaking noise in center console area on model series 176 and model series 117

| Topic number | LI68.20-P-058781 |
| Design group | 68.20 Center console |
| Validity | Model series 176 and 117 up to production date 24.02.2014 |

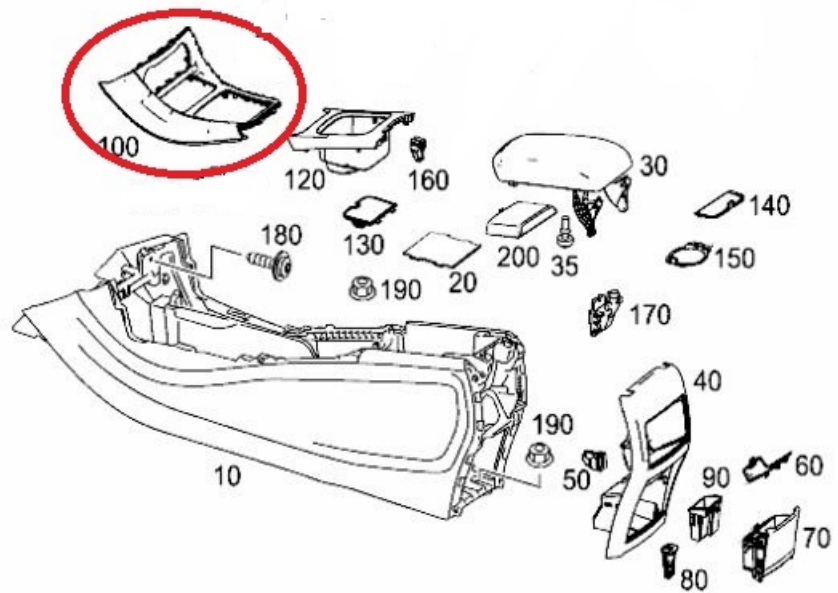
1.JPG:

The trim on the A/C operating unit makes noises.

| Attachments | |
|---|---|
| 1.JPG | EPC picture |

Replacement of trim on A/C operating unit.

Determine the optimized trim parts via the EPC.
