## Noise on left/right door power window when moving up/down

| Topic number | LI72.10-P-065523 |
| Design group | 72.10 Front door |

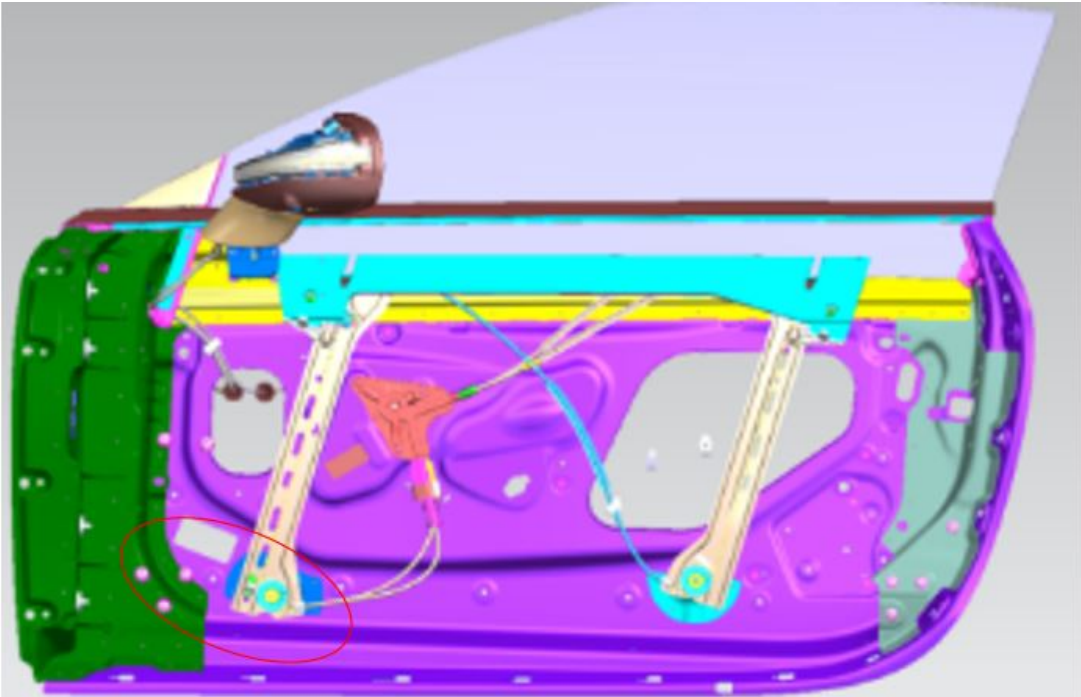
Bild 1.JPG:

Interference of side window pane with door wiring harness protection, when window is in lowered position.

1. Remove outer sealing rail for window.
2. Lower side window pane
3. Perform visual inspection to see if side window pane interferes with door wiring harness protection.
4. If interference occurs, adjust wiring harness out of the way and replace side window pane if necessary.
