## Friction noise on left side of stretch cover for both driver seat backrests when deflating dynamic seat

Topic number	LI91.10-P-065541
Version	1
Design group	91.10 Front seats
Date	01-13-2017
Validity	Model series X222 (Maybach)
Reason for change	
Reason for block

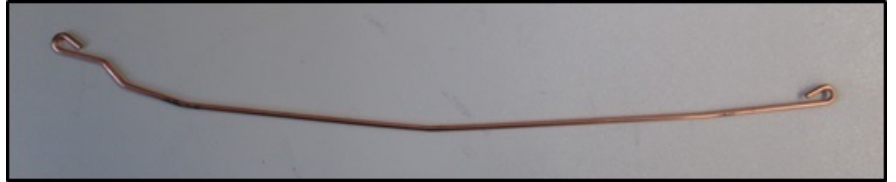
1.jpg:

The stretch cover may generate friction noise at the eyelet of wire hooked into backrest

1. Dismantle backrest trim (see AR91.10-p-1910lf)
2. Remove hook-in wire (Pic. 1) from left seat (Pic. 2)
3. Felt strip (A 001 983 23 10 - Cut felt strip 40x2) to length of 20 mm and fix in place around eyelet for hook-in wire (Pic. 3, Pic. 4)
4. Reinstall hook-in wire
5. Mount backrest trim (see AR91.10-p-1910lf)
