SI B11 15 17
Engine

B46/48 ENGINE: OIL LEAK FROM TURBOCHARGER RETURN LINE

This Service Information bulletin replaces SI B11 15 17 dated **October 2017**

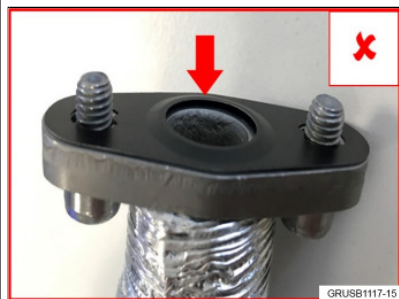
Exhaust turbocharger, oil return line leaking at connection to turbocharger.

Incorrect assembly of the "asbestos-free gasket". The gasket was incorrectly flipped during installation with the bead raised toward the turbocharger, as shown.

Parts replacement and correct installation.
