SI B11 18 17
Engine

DELIVERY STOP: REPLACE FLYWHEEL BOLTS

MODEL

F15 PHEV (X5 eDrive)	F26 (X4)	
----------------------	----------	--

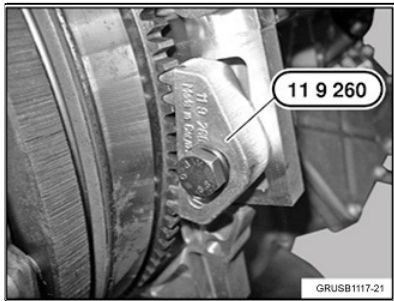
The flywheel bolts may not be tightened to the correct torque.

Incorrect tightening torque used during assembly.

<p>After removing of the transmission, secure the flywheel using the special tool 119 260.</p>
	<p>Replace six M12x19 bolts (PN 11 22 7 522 125 for F26 X4, or PN11 22 7 520 706 for F15 PHEV). Do not remove flywheel. Torque flywheel bolts in two stage process:</p> <ul style="list-style-type: none"> • joining torque: 60 Nm
