SERVICE ACTION: INSPECT / REWORK DME CONNECTOR

This Service Information bulletin replaces SI B12 17 17 dated **October 2017**

F30 (3 Series Sedan)

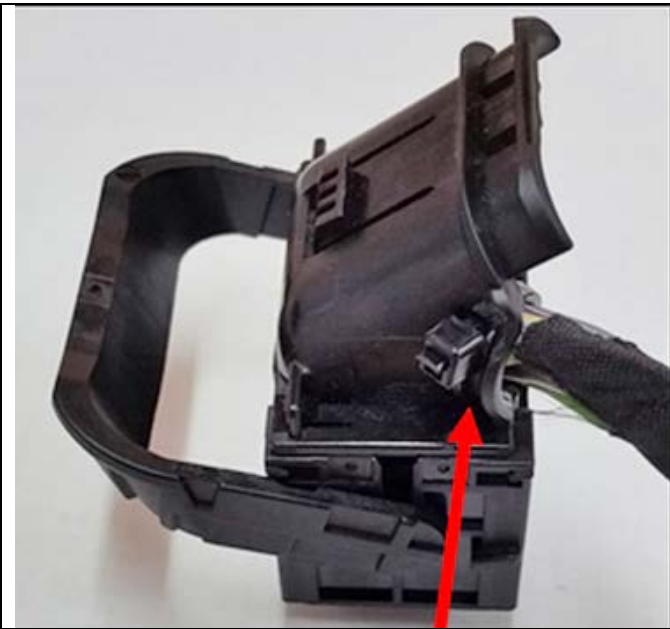
<p>1c. Locate connector A368*1B and remove it from the DME.</p>
	<p>1d. Check for water residue or corrosion in the connector and in the connector chamber of the DME control unit (photo below).</p>
	<p>1e. Evaluation:</p> <p>If <u>no</u> water residue can be found on either component, proceed to "2. Rework the connector".</p> <p>If <u>water residue or corrosion is observed</u> in the connector, proceed to "3. Replace partial wiring harness and DME control unit".</p>
<p>2. Rework the connector:</p>

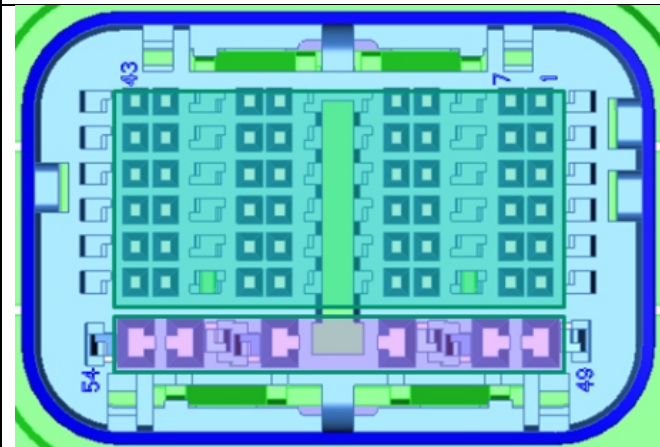
2d. All slots in the connector must be occupied with a wire or sealing plug.

2e. Install suitable sealing plugs (Repair kit P/N 61 12 8 794 765) into all of the open chambers.

Fit green sealing plugs into the open chambers in positions 1 thru 48 on connector A368*1B

Fit "natural colored" sealing plugs into the open chambers in positions 49 thru 54
