SI B31 04 17
Front Axle

December 2017
Technical Service

SERVICE ACTION: CHECK, AND IF REQUIRED, REPLACE THE RIGHT FRONT HALF SHAFT

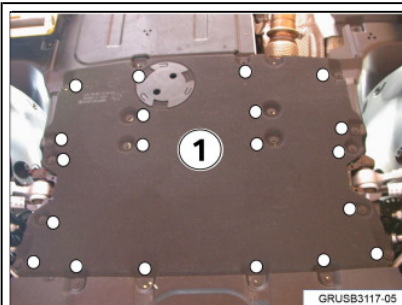
Remove the center lower protection cover (1).
Tightening torque of screws when reinstalling is 3Nm.

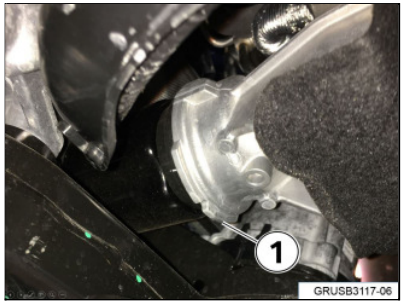
<p>GRUSB3117-06</p>

Check the right side output shaft where it enters the extension housing (1) for an oil leak. If oil is leaking, replace the output shaft. Follow Repair Instruction **31 60 000 Removing and installing/replacing left or right output shaft**.

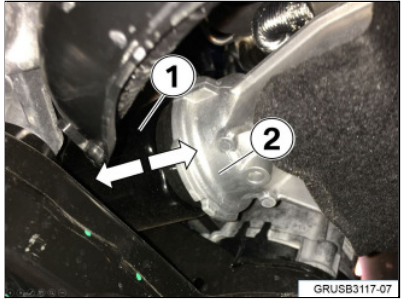
<p>GRUSB3117-07</p>	<p>If there is no oil leak: Check for play in the output shaft (by hand) and pull the half shaft (1) as far as possible away from the extension housing (2).</p>

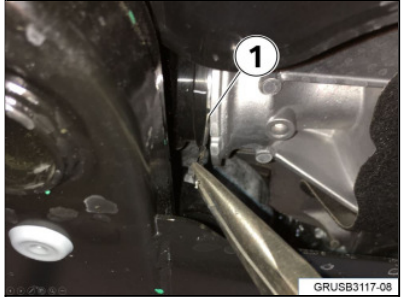
<p>GRUSB3117-08</p>	<p>Insert a 3mm feeler gauge (3mm drill bit shown) into the gap between the output shaft and the extension housing (1). If the feeler gauge fits tight or will not fit (gap is $\leq 3\text{mm}$) then no further repair is necessary. If the feeler gauge fits loose (gap $>3\text{mm}$), replace the output shaft. Follow Repair Instruction 31 60 000 Removing and installing/replacing left or right output shaft. (Right Side - KSD2: 31 60 504)</p>
