NOISE WHEN ADJUSTING THE STEERING COLUMN UP OR DOWN

This Service Information bulletin replaces SI B32 01 15 dated July 2015

F15 (X5)	F16 (X6)	F85 (X5 M)	F86 (X6 M)
----------	----------	------------	------------

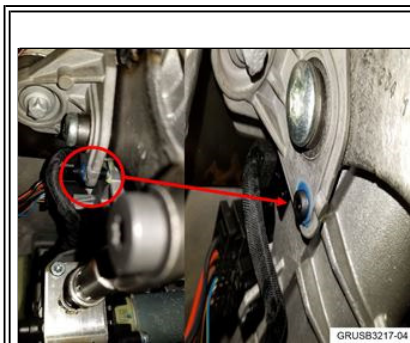
Verify if the noise occurs when raising or lowering the steering column position.

1. Remove the steering column shroud as per the repair instruction RA 32 31 020, Removing and installing lower section of steering column shroud
2. Adjust the steering column position up and down and check if the noise is present.
 - a. If the noise does not continue with the shroud removed, reinstall the upper and lower shroud sections and repair as necessary (adjust the proper position of the shroud)
 - b. If the noise continues, proceed to step 3
