Trunk Lid Does Not Open Completely

This Service Information bulletin replaces SI B51 13 14 dated **May 2014**.

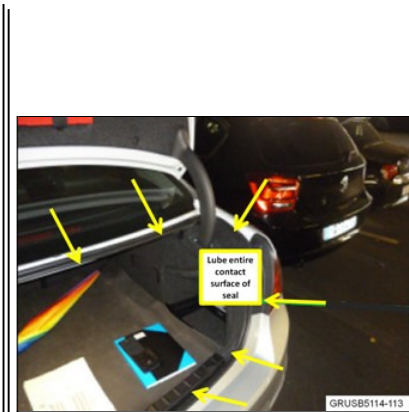
Adhesion between body and unlubricated trunk lid/hatch seal.

<ol style="list-style-type: none"> 1. Open the trunk and clean the entire rubber seal surface that contacts the trunk lid. 2. Allow seal to dry. <p>

Note: The seal must be completely dry before</p>
--	--

applying any lubricant..

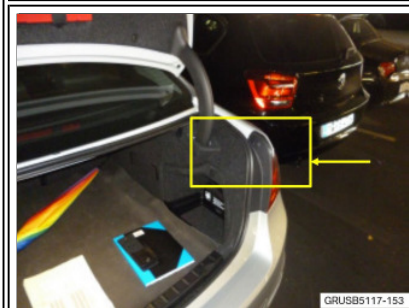
Incorrectly installed trunk lid tension spring may also not fully open a trunk lid.

- On F30, F32, F80 and F82, partially remove the upper part of the luggage compartment side trim panel to expose the trunk spring.
