SI B63 09 17  
Lights

## REAR TAIL LIGHT FAILURE

F30 (3 Series Sedan)	F31 (3 Series Sport Wagon)	F32 (4 Series Coupe)	F33 (4 Series Convertible)
F34 (3 Series Gran Turismo)	F36 (4 Series Gran Coupe)	F80 (M3 Sedan)	F82 (M4 Coupe)
F83 (M4 Convertible)

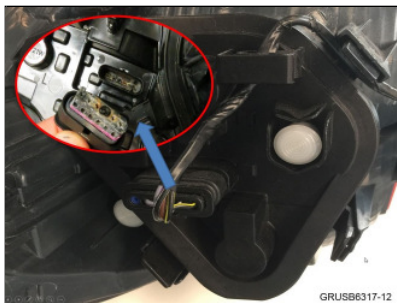
Burnt pin in connector from wiring harness to rear lamp assembly bulb holder.

3. Inspect the condition of the pins on the harness connector and on the bulb holder.

Replace bulb holder and wiring harness connector, if damaged.

**YES-** replace the bulb support according to REP 63 21 030 Removing and installing/replacing left socket housing for rear light (on side wall) and wiring harness connector then go to Step 4.
