MISSING DISPLAY OF SURROUND VIEW CAMERA

This Service Information bulletin replaces SI B66 17 17 dated **October 2017**

G12 (7 Series)	G30 (5 Series Sedan)	G01 (X3)	G32 (6 Series Gran Turismo)
----------------	----------------------	----------	-----------------------------

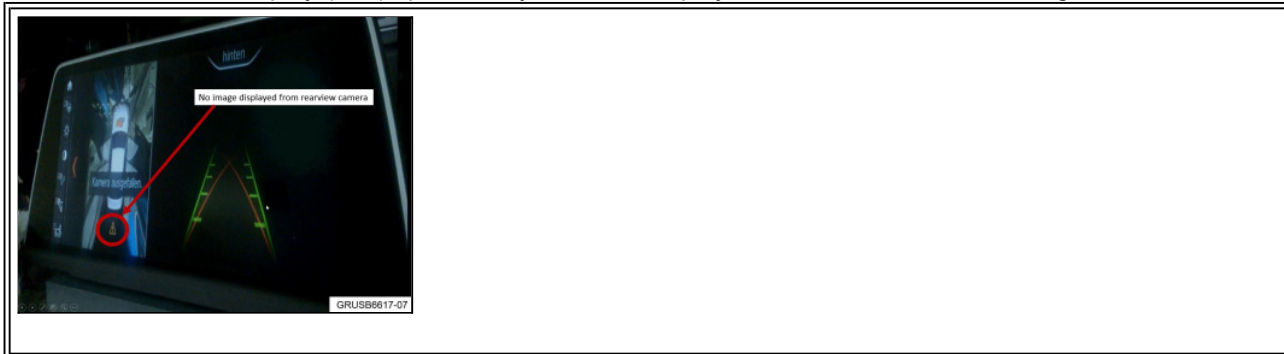
Central Information Display (CID) sporadically does not display Surround View Camera image.

The following fault memory entries are stored in the Surround View camera (ICAM2) control unit:

- 0x800ba5 Rear view camera: Internal camera fault
- 0x800b90 Rear view camera: max. permissible current exceeded

Software for the ICAM2 control unit.

Reprogram the vehicle with ISTA 4.08.24 or a more recent version.

1. Perform diagnosis with the latest version of ISTA.
2. Program the vehicle using ISTA 4.08.24 or more recent version.

Target integration level: 17-11-520 or higher
