SI M41 02 17
Body

SERVICE ACTION: LEFT SIDE SILL INSPECTION-REPAIR

F57 (Cooper, Cooper S, JCW Convertible)			
---	--	--	--

DOOR SILL CRACK REPAIR

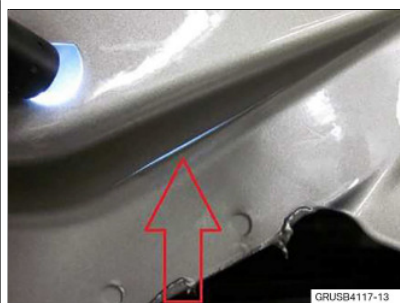
A production issue during panel formation, has led to the possibility of cracks being created in the radius of the outer left side frame (below the side sill trim panel).

<ol style="list-style-type: none"> 1. Remove the left side sill trim panel as detailed in REP 51 71 447 "Removing and installing/replacing the side sill trim panel on the left or right side."
	<ol style="list-style-type: none"> 2. Check for a crack in the side sill by shining a light into the opening for the clip as shown. <p>Does light shine through the crack near the inner radius of the side frame?</p>

YES- follow the attached repair procedure -
M410217_Attachment-Door Sill Crack Repair
