SI M51 08 17  
Body Equipment

## TRUNK OPEN MESSAGE ON CLUSTER

F55 (Cooper, Cooper S, JCW Hardtop 4 door)

F56 (Cooper, Cooper S, JCW Hardtop 2 door)

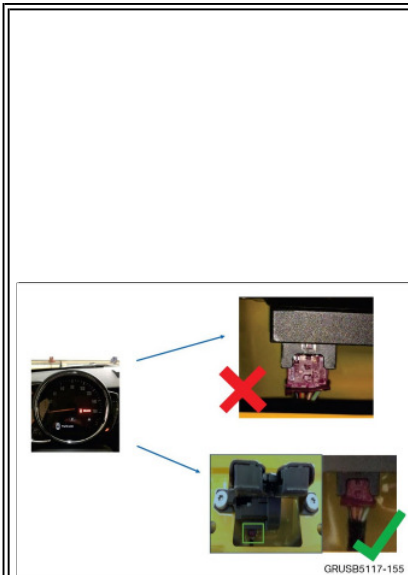
Improper mating of trunk lock connector.

**Was plug properly joined with the tailgate lock connector as shown in graphic?**

Properly attach trunk lock connector.

**NO –** reconnect plug into connector (it should click into place when fully inserted).
