US 63887869-01

Fault in crankshaft sensor

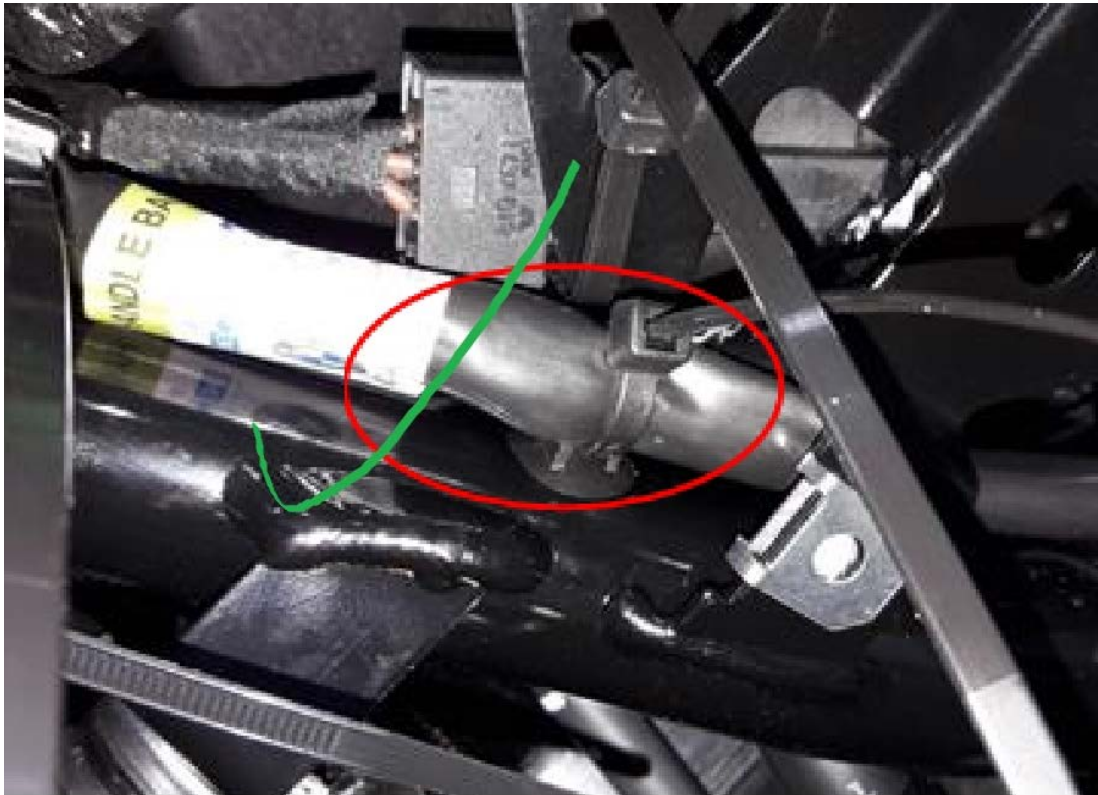
**Correct Placement**

The plug in the area of the engine control unit must also be repositioned: It must be mounted BEHIND instead of IN FRONT OF the wiring harness, so that the lines there are no longer bent in an unacceptable manner! (see attachment)

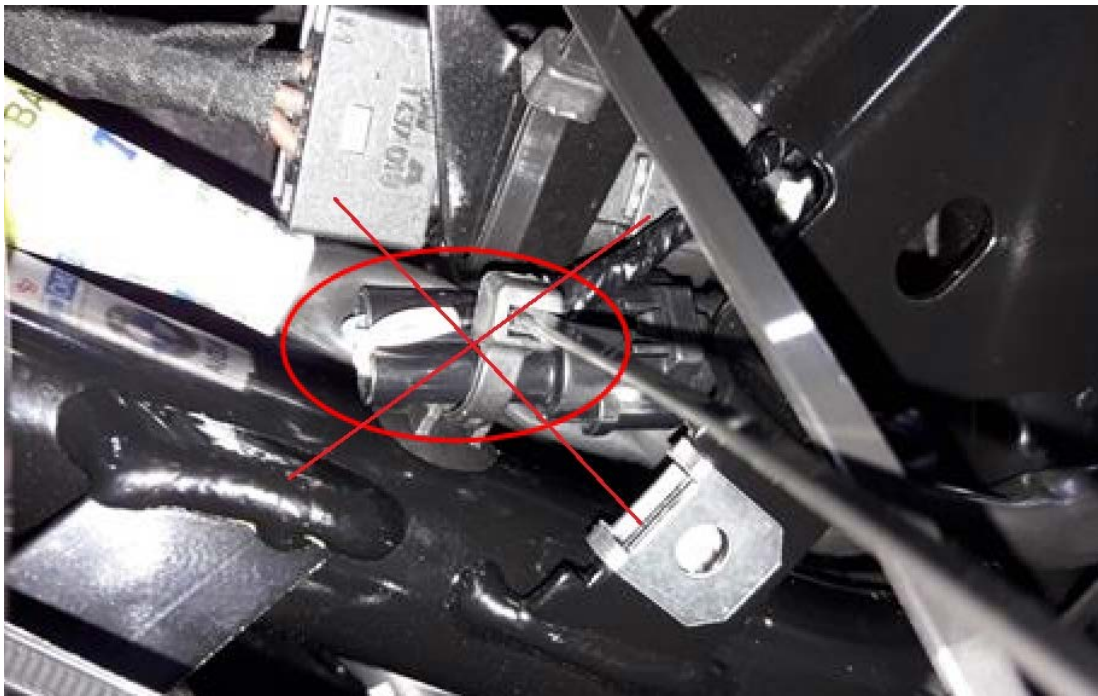
There could be damage to both wires going to and from the crankshaft sensor.

**Incorrect Placement**
