# Service Bulletin

**Subject:** Active Shutters Inoperative, Malfunction Indicator Lamp (MIL) Illuminated

Brand:	Model:	Model Year:		VIN:		Engine:	Transmission:
				from	to		
Buick	LaCrosse	2017	2017				
Chevrolet	Malibu (VIN Z)	2016	2017

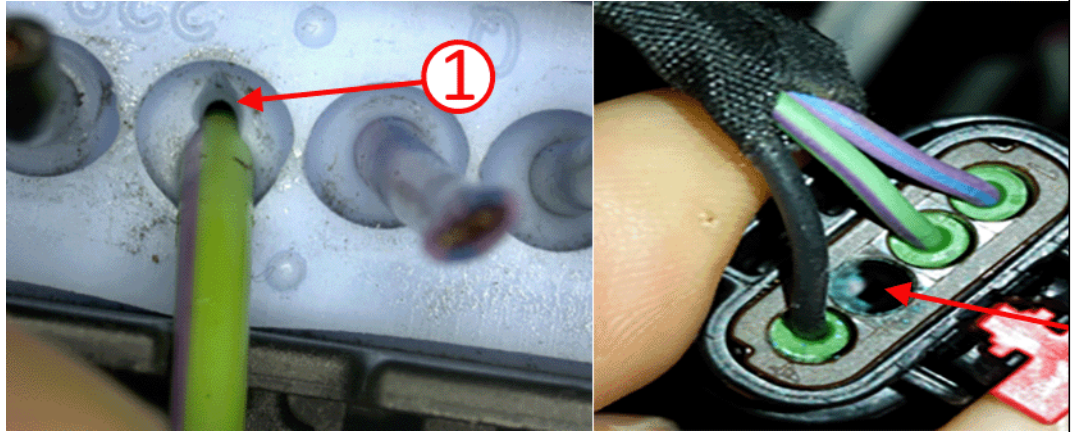
This condition may be caused by the following conditions:

- Moisture intrusion past damaged (1) and/or missing (2) seals located in the B9, M60B and/or X119 connectors for the ambient air temperature sensor wiring harness.
- Snow and/or ice buildup in the front lower grille area of the vehicle, which could prevent the active aero shutters from opening or closing.

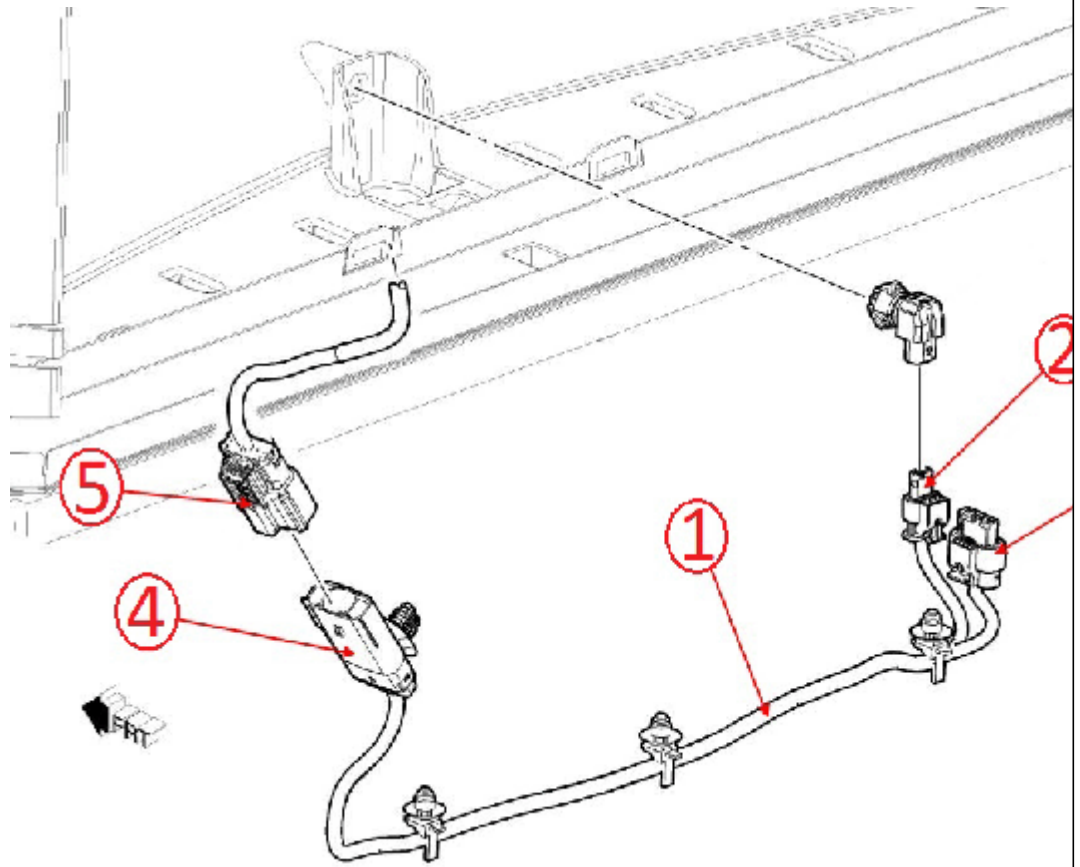
Inspect the ambient air temperature sensor wiring harness connectors B9 (2), M60B (3) and the X119 (4, 5) for any signs of corrosion.

**Notice:** The Ambient Air Temperature Sensor Wiring Harness must be replaced and dielectric grease must be applied to all of the connectors for any of the following repairs.

- If any signs of water and/or corrosion was found on the Ambient Air Temperature Sensor Wiring Harness (1), it must be replaced.
- If water and/or corrosion was found at the X119 connector (5), the main body wiring harness connector must be replaced.
- If water and/or corrosion was found at the B9 connector (2), the ambient air temperature sensor must be replaced.
- If water and/or corrosion was found at the M60B connector (3), the active shutter must be replaced.
