# Service Bulletin

**Subject:** Brake Pedal Squeak Noise Heard When Applying and Releasing Brake Pedal/Cruise Control Inoperative or Disengaged

Brand:	Model:	Model Year:		VIN:		Engine:	Transmission:
		from	to	from	to		
Chevrolet	Volt	2016	2017

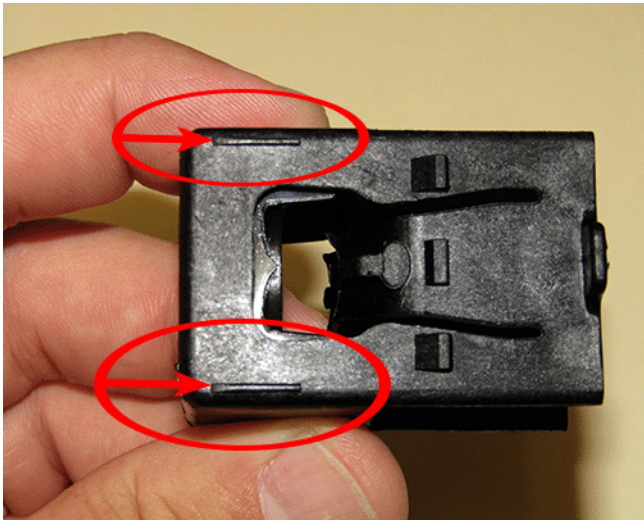
**Note:** The new retainer has two raised ears on both sides located on the front, which will cause an interference fit when installing.
