# Service Bulletin

**Subject:** No Heat and/or Cooling, Temperature Control Setting Does Not Match What is Selected on Heater and Air Conditioning Remote Control

| Brand: | Model: | Model Year: | | Vehicle Build Dates: | | Engine: | Transmission: |
|---|---|---|---|---|---|---|---|
| Chevrolet | Bolt EV | 2017 | 2017 | SOP | January 31, 2017 | | |

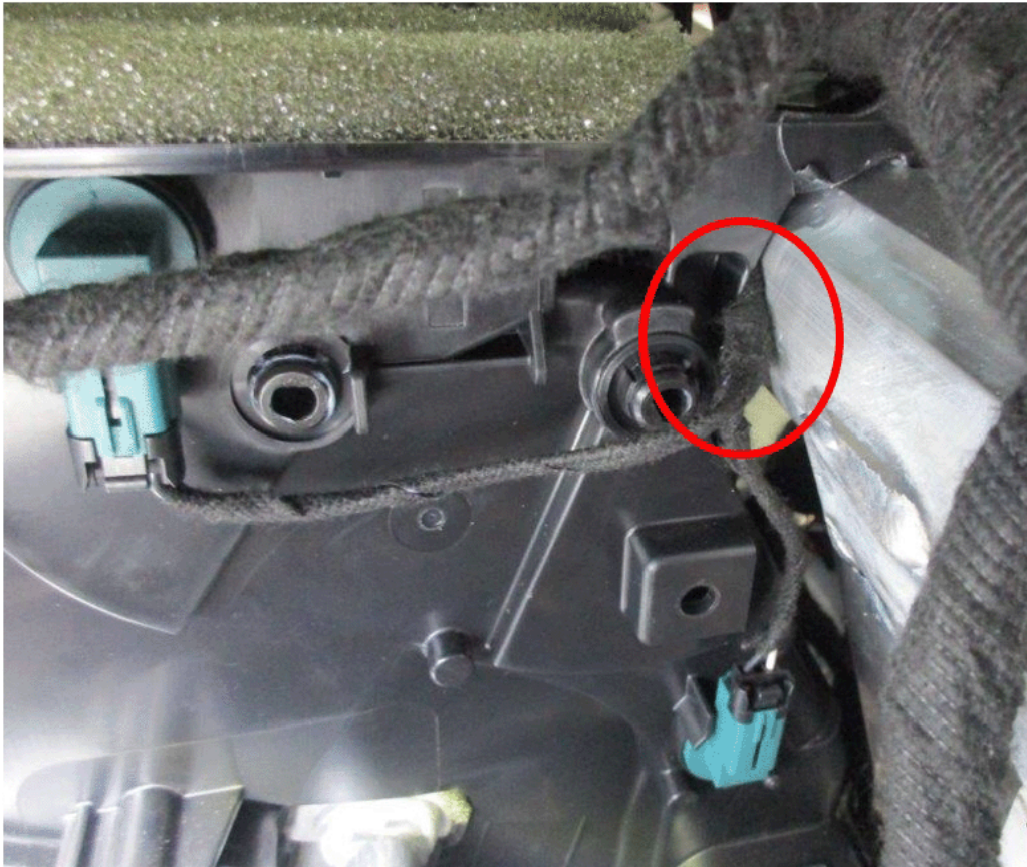
| <p><b>Cause</b></p> | <p>This condition may be caused by the duct temperature sensor wire harness pinched between the HVAC case module assembly and the tie bar.</p> |

| <p><b>Correction</b></p> | <p>Inspect and repair any damaged wiring and relocate the harness towards the bottom of the tie bar so the harness does not get pinched.</p> |

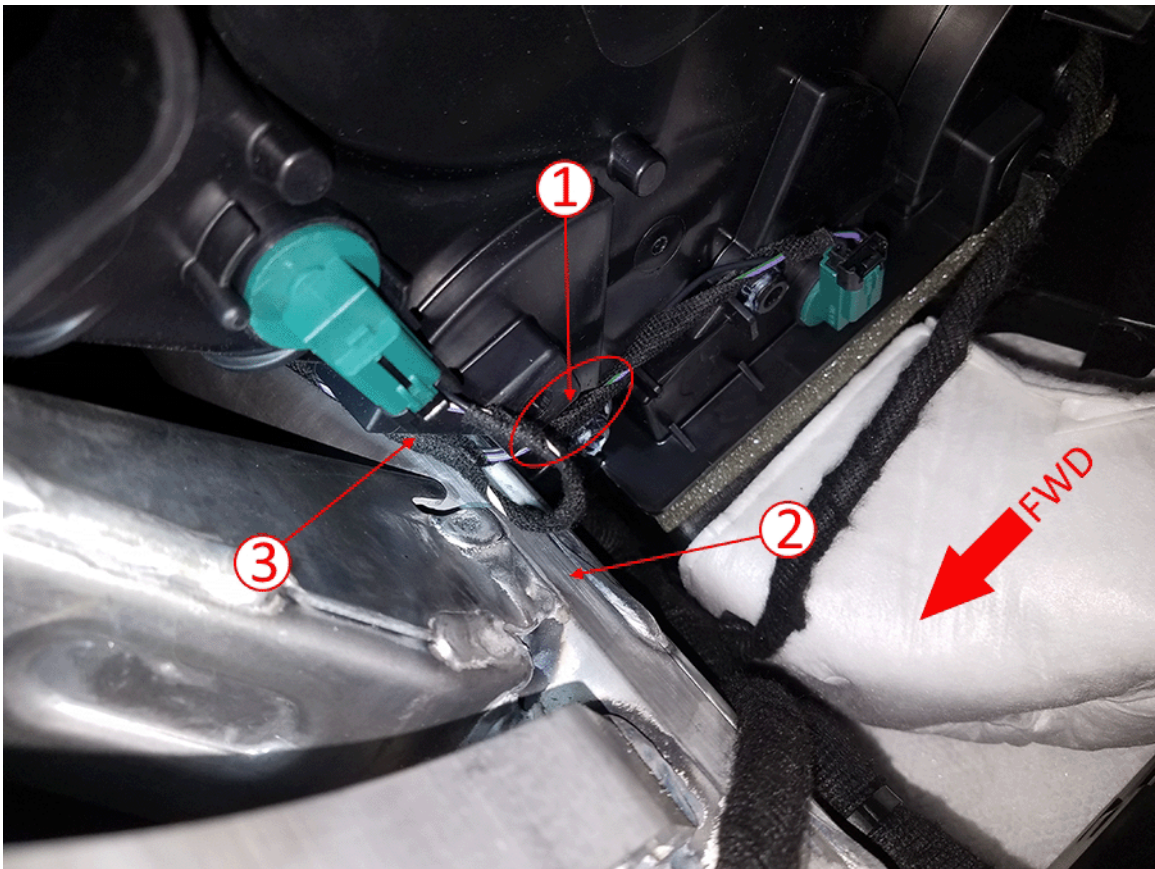
2. While looking upwards at the duct temperature sensor wiring harness, grab the harness (3) and check for movement between the tie bar (2) and the HVAC housing.

- If the wiring is moving freely from the tie bar and routed properly (1), **Do Not** proceed with this procedure and refer to SI for further diagnostics.
- If the wiring is pinched between the tie bar and HVAC housing, proceed with this procedure.

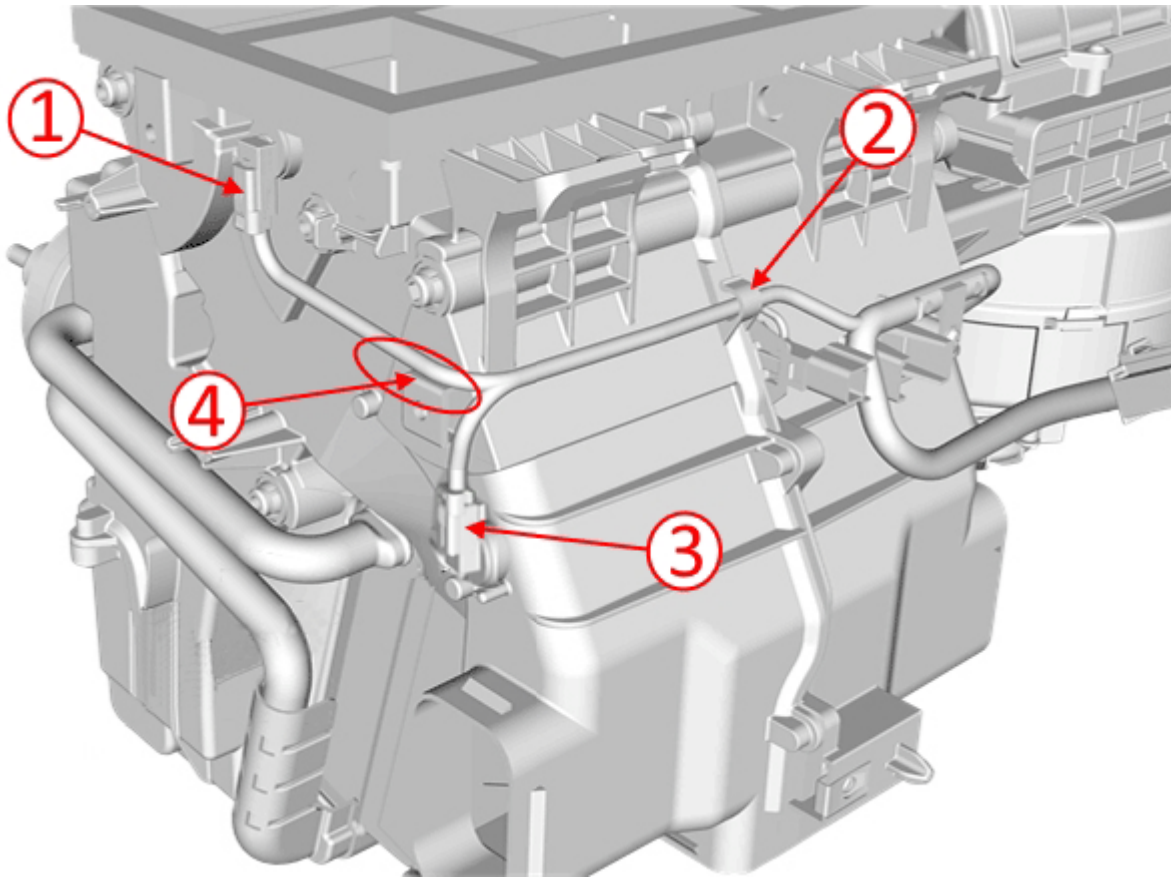
6. Disconnect the upper (1) and lower (3) air duct temperature sensor wiring harness connectors.
7. Inspect the wiring harness (4) for signs of damage.
8. Repair the wiring harness as needed. Refer to *Wire-to-Wire Repair* in SI.
9. Using Woven Polyester Electrical Tape (PET), tape the harness ensuring that the tape is applied in a double layer extending along the harness past the contact points.
10. Route the wiring harness under the tie bar.
  - Validate the harness is routed through the retainer (2).
11. Connect the upper and lower air duct temperature sensors electrical connectors.
12. Install the upper and lower heater and air conditioning evaporator case fasteners.
13. Install the instrument panel assembly.
