Service Bulletin

Subject: Water Sloshing in Quarter Panel Area When Accelerating or Stopping and/or Long Period of Water Draining from Rear Wheel Well After Vehicle is Parked

Brand:	Model:	Model Year:		VIN:		Engine:	Transmission:
		from	to	from	to		
Buick	Cascade	2016	2017			All	All

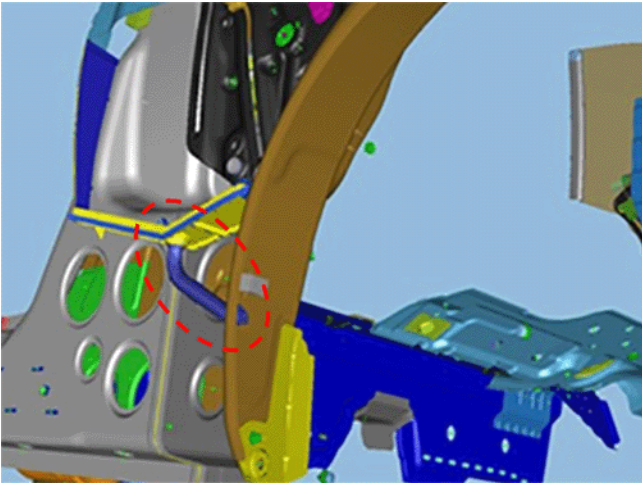
Note: The drain hose (shown circled above) runs from the quarter window cavity to the wheel well. A blockage or clog could occur at either end of the hose.

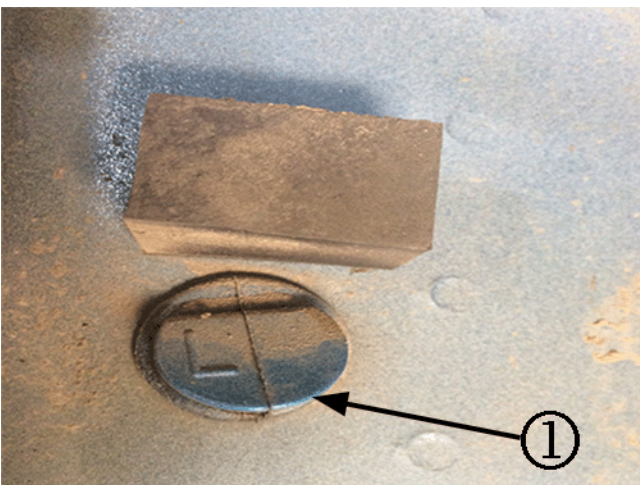
Note: Inspect for, and remove, any paint that may be holding the drain flap (1) shut.
