Service Bulletin

Subject: Instrument Panel (IP) Compartment Door Squeak

Brand:	Model:	Model Year:		VIN:		Engine:	Transmission:
		from	to	from	to		
Chevrolet	Equinox (VIN X)	2018	2018				
GMC	Terrain	2018	2018

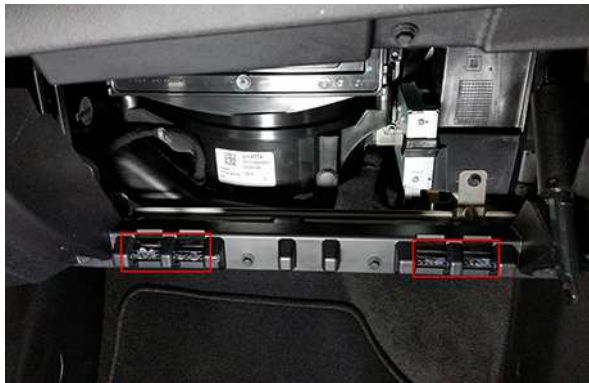
Involved Region or Country	North America, Middle East, Israel
Condition	Some customers may comment that the IP compartment door (glove box) squeaks when opening or closing.
Cause	This condition may be caused by interface between the plastic hinge components at cold ambient temperatures.
Correction

<p>Remove the IP compartment door and apply dielectric grease to the two hinges.</p>
