Service Bulletin

Subject: Malfunction Indicator Lamp (MIL) Illuminated - DTC P151E Set

Brand:	Model:	Model Year:		VIN:		Engine:	Transmission:
		from	to	from	to		
Chevrolet	Colorado Models	2016	2017			LFX, LCV, LGZ	
GMC	Canyon

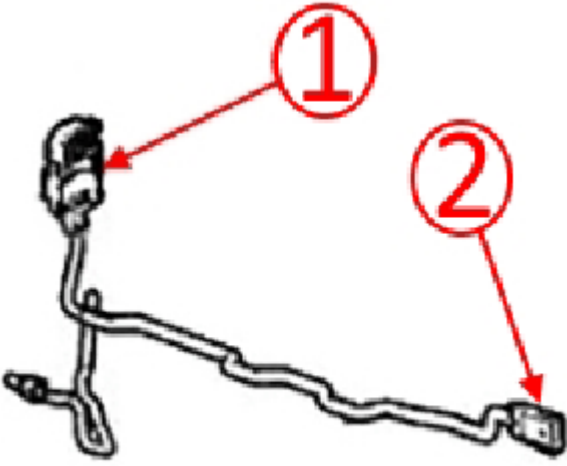
Involved Region or Country	North America
Condition	Some customers may comment that the MIL is illuminated. The technician may find DTC P151E set.
Cause	This condition may be caused by a poor connection at the X105 connector.
Correction	<p>Note: Do Not replace the active shutter until the electrical connection has been validated.</p>

<p>If the DTC P151E code is set, the X105 connector (2) at the active grille air shutter motor (1) must be checked for proper connection.</p>

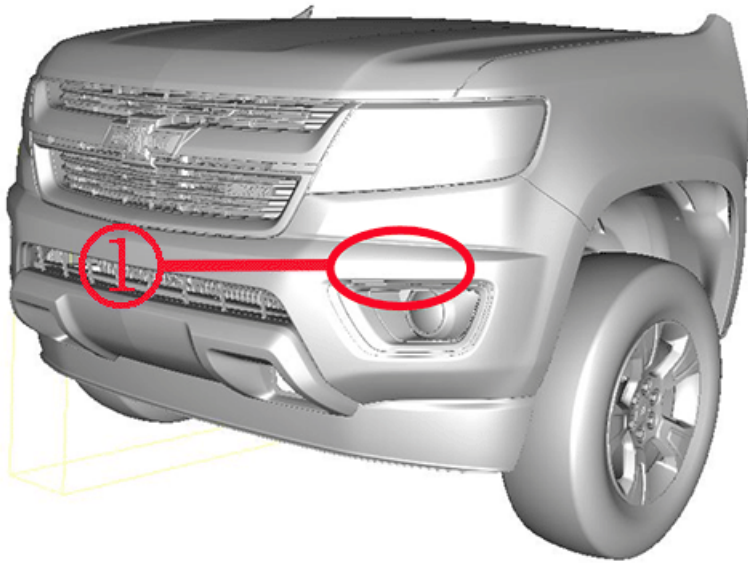
Note: The connector X105 is located behind the left side of the fascia (1) attached to the tiebar. The fascia **Does Not** need to be removed for this procedure.

1. Turn the ignition OFF and allow time for the vehicle to power down.
 - It may take up to 2 minutes for all vehicle systems to power down.
2. Partially raise and support the vehicle. Refer to *Lifting and Jacking the Vehicle* in SI.
3. Turn the steering wheel all the way to the right.
4. Remove the fasteners in the front half of the wheel liner in the wheel well, pull the wheel liner back, and tuck it behind the LF wheel.

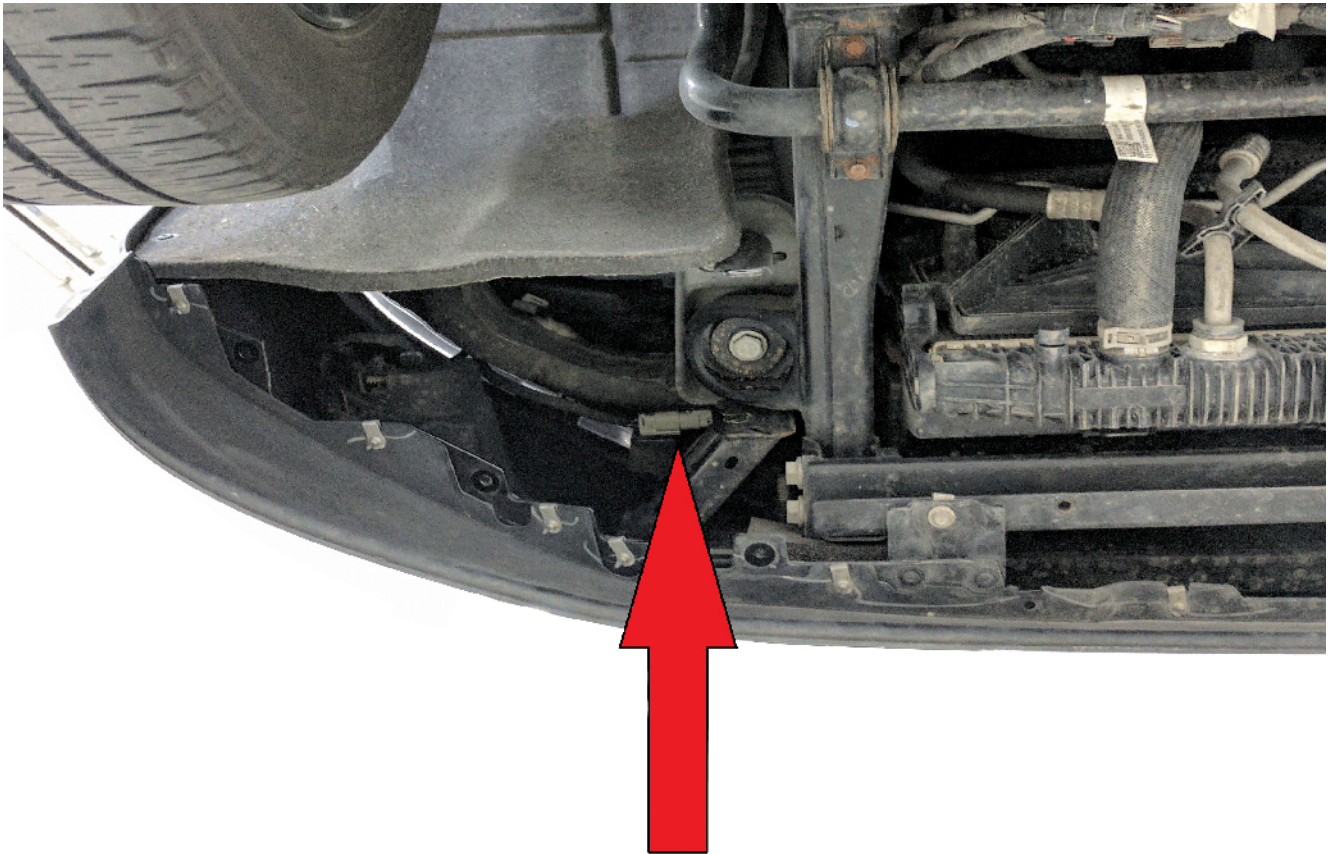
Note: The graphic above shows the lower fascia support removed for clarity of connector location.

5. Reach through the opening to the front lower left corner of the cooling module to locate X105.
6. Disconnect the X105 electrical connector for the active grille air shutter motor.
7. Apply dielectric grease in connector.
8. Connect the wiring harness connector.
9. Install the wheel liner.
10. Lower the vehicle.
11. Verify that DTC P151E is not set.
 - If the DTC has not set, repair completed.
 - If the DTC sets, refer to SI for further diagnostics.
