Service Bulletin

Subject: Exterior Roof Panel Sag/Depression

Models: 2013-2017 Chevrolet Express Extended Vans (Passenger and Cargo)
2013-2017 GMC Savana Extended Vans (Passenger and Cargo)

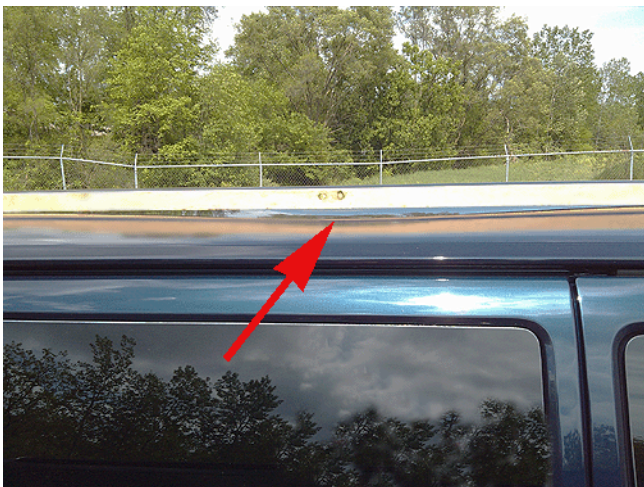
Some customers may comment that a sag/depression area appears on the roof of the vehicle at times and then goes away. This condition is most prevalent on dark colored vehicles. The affected area is 3 to 7 feet (0.9-2.1 m) from the rear edge of the roof with the deepest depression at 5 feet (1.5 m) from rear edge. The sag appears when the van is sitting outside in the sun and it will go away when van roof surface cools down but will reappear when parked back in the sun. This sag is most prevalent on the passenger side of the vehicle. In some rare cases it may also appear on the driver side.

This condition is caused by an insufficient amount of (anti-flutter) sealer between the third and fourth roof bows and the outer panel. As the roof panel expands in the sunlight, the sealer does not expand as intended, causing the low areas to appear.

Use the following steps to remove the sealer (anti-flutter) in the affected area and install shim material.
