Service Bulletin

PRELIMINARY INFORMATION

Subject: Rear Vision Camera Display Does Not Fill Radio Display Completely

Models: 2014-2015 Chevrolet Spark
2014-2016 Chevrolet Sonic, Trax
Equipped with RPOs UF7 and UVC

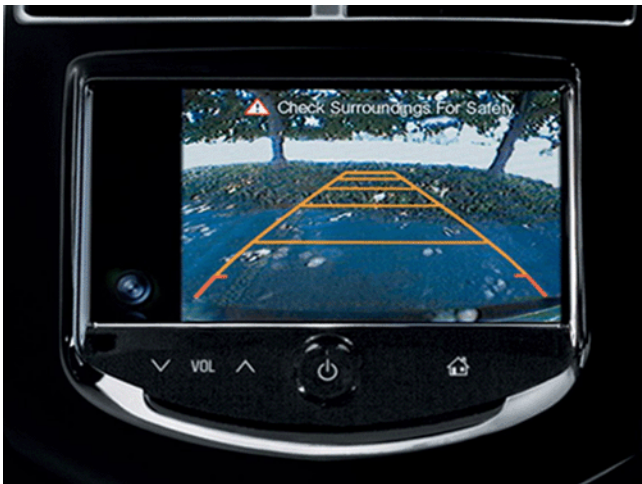
Some customers may comment that when using the rear vision camera, it only shows on 3/4 of the radio display screen.

This is a normal characteristic of this radio display and the rear vision camera. Do not replace any parts.
