Preliminary Information

PIP5493C Misfire with DTC's P0300, P0301-P0306

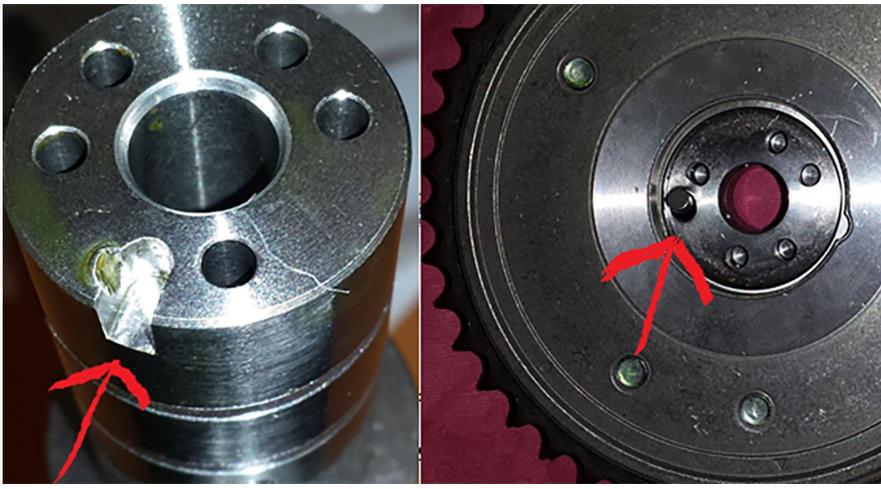
a) If misfire counts accumulate on all three cylinders on one bank, inspect the AFM rocker arms for operation or breakage. Inspect intake and exhaust camshaft and sprocket pins on that bank.

b) If misfires are on cylinder 2 or 5 (AFM), inspect the AFM rocker arms and inspect intake and exhaust camshafts and sprocket pins on that bank.

Call TAC and replace the exhaust DFSHLAs with the sorted spec part as well as the AFM OCV.

Replace and or repair the rockers, SHLAs, DF SHLAS, actuator and camshaft as needed per damage found.
