Preliminary Information

PIP5248D Stalling Shudder And/or Hard shifting Into 1st Gear Or Reverse Vibration On launch (With Excessive Crankshaft End Play)

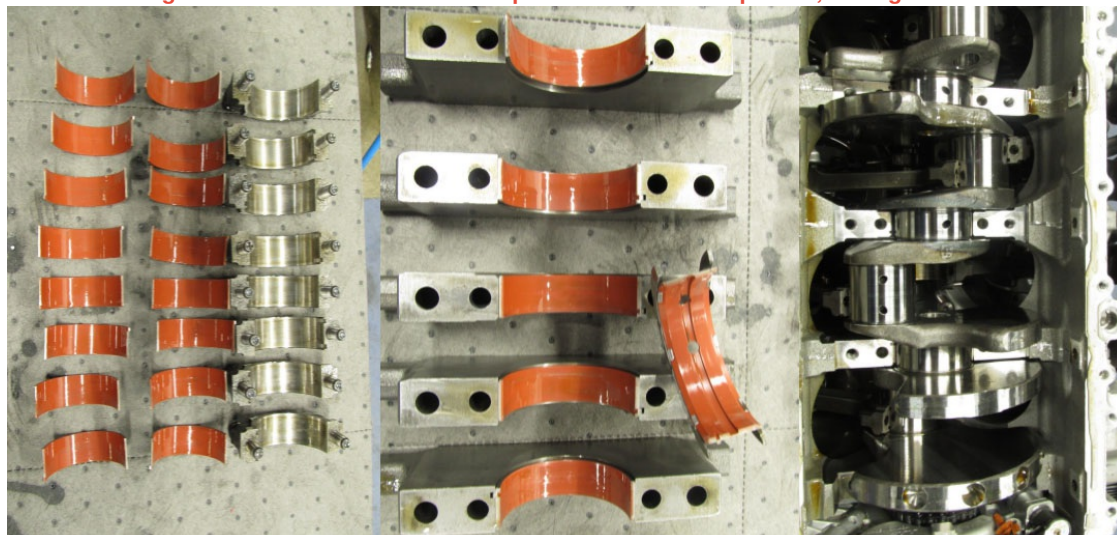
This concern could be caused by excessive crankshaft end play.

Check to determine if the crank shaft end play is within specification 0.0015–0.0086 in (0.040–0.220 mm). See eSI.

If end play is found to be out of specification, remove engine and inspect for possible Crankshaft thrust bearing and/or crankshaft for wear.

Note: If bearings and crankshaft look like components in attached picture, damage has not occurred.

Inspect thrust bearing for wear on one side and crankshaft on that “mating” surface.

If wear is evident (3 vertical channels worn off) replace connecting rod bearings, main bearings, thrust bearing and crankshaft.

For this repair the oil tank with lines and oil cooler are both required to be replaced if equipped.

Note; It is required on dry sump engines, the oil tank and lines should be replaced when replacing and/or repairing the engine.

Also Note; If equipped, the oil cooler is also required to be replaced.
