Preliminary Information

PIT5119E Intermittent Remote Keyless Entry Inoperative

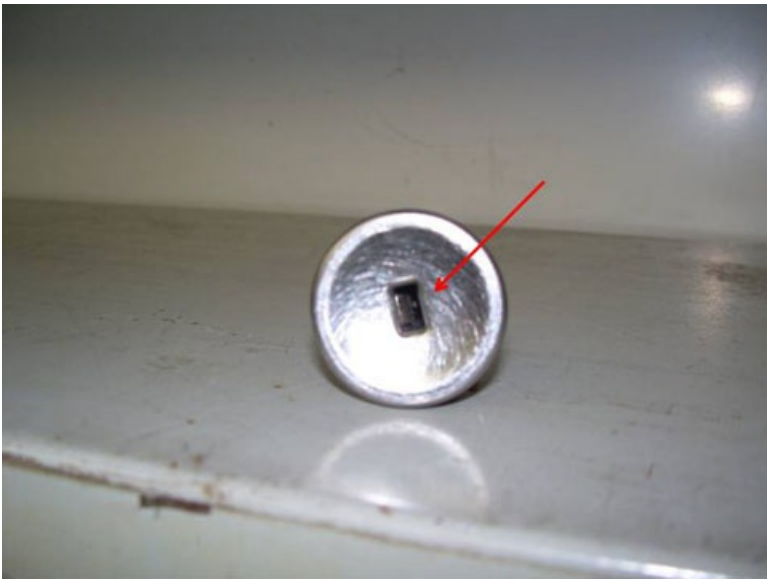
Customer may comment the keyless entry remote is inoperative at times. This may be caused by the ignition key cylinder door sticks in the up position. When this happens it will disable the keyless remote start and the door lock functions. Customers may notice a Chime sound when the key is out of the ignition and the driver's door is open. The likely cause is a sticking ignition key cylinder door on plunger to the micro switch.

Ignition key door sticking open

Use a Lubriplate type of lubrication spray and lubricate the ignition key cylinder door. Insert the tip of the key in and out to verify the door of the cylinder is not sticking.
