Preliminary Information

PIT5579 Tick Creak Rattle Noise

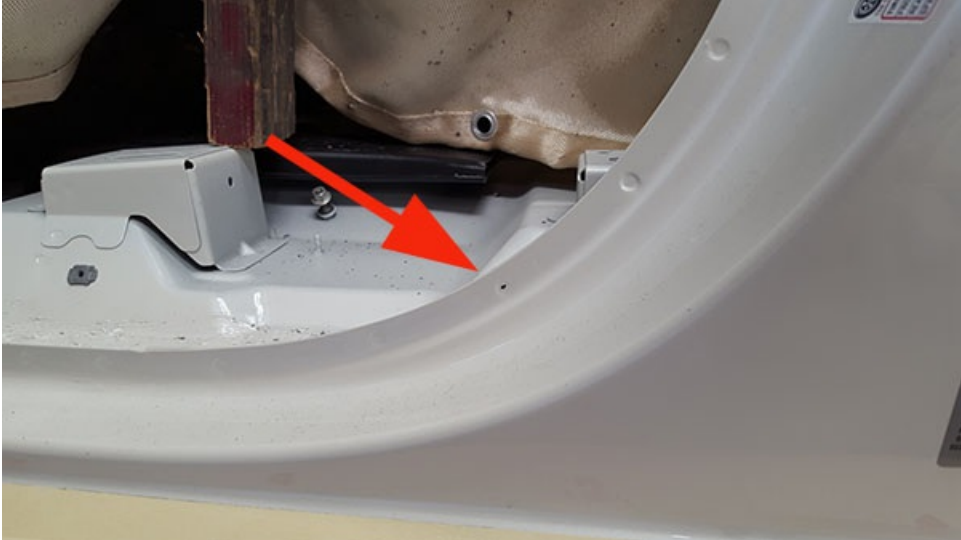
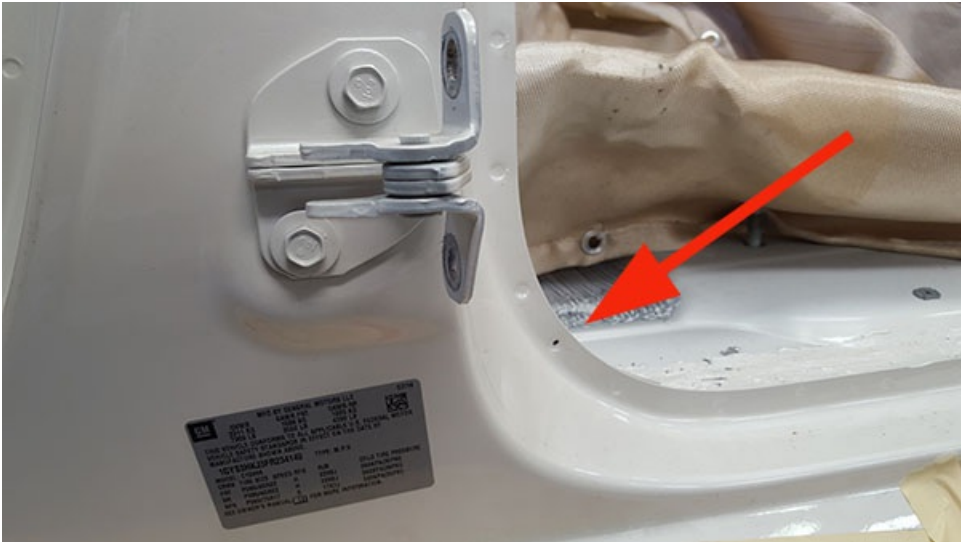
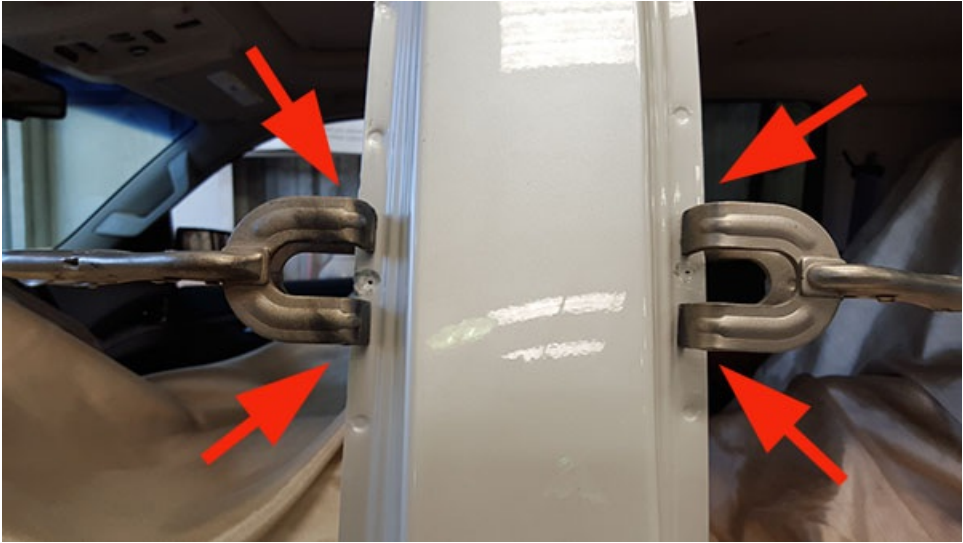
Condition 1: Inspect for missing or incomplete welds near the base of the B pillar.

Repair welds as necessary
Condition 2: Inspect B pillar in area near seat belt mounting where there are three pieces of sheet metal sandwiched together for contact between the panels.

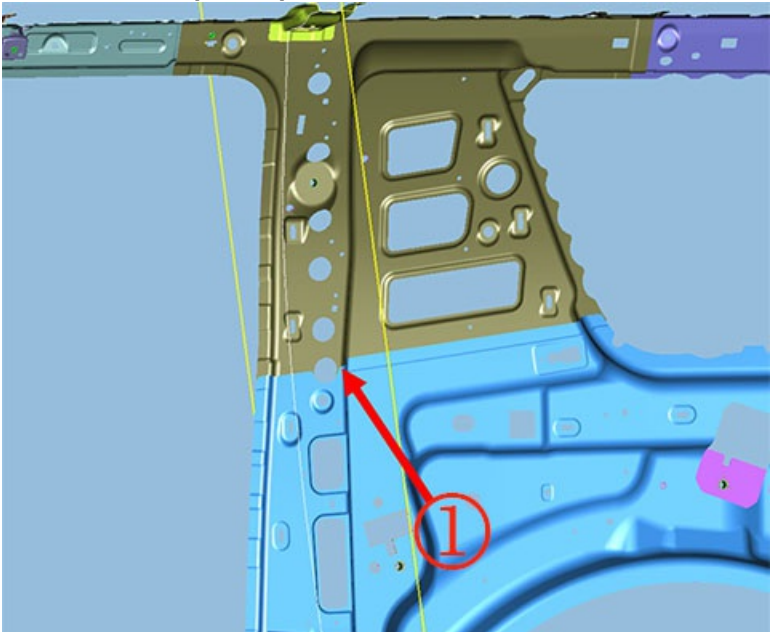
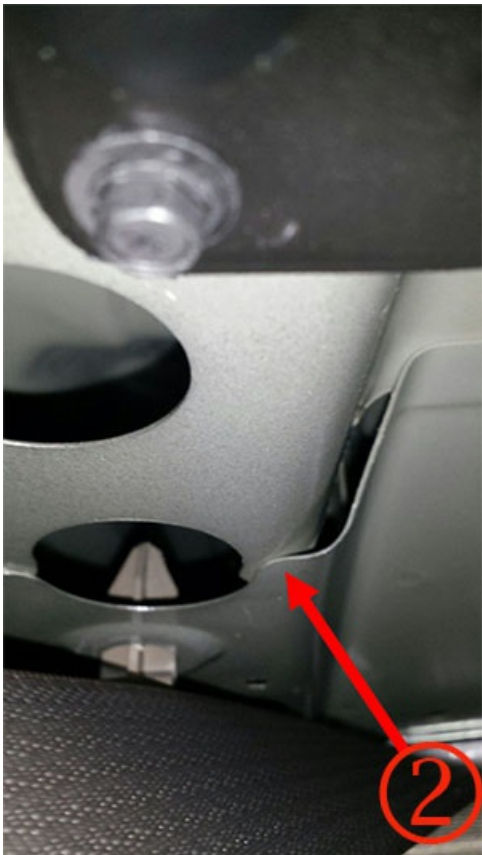
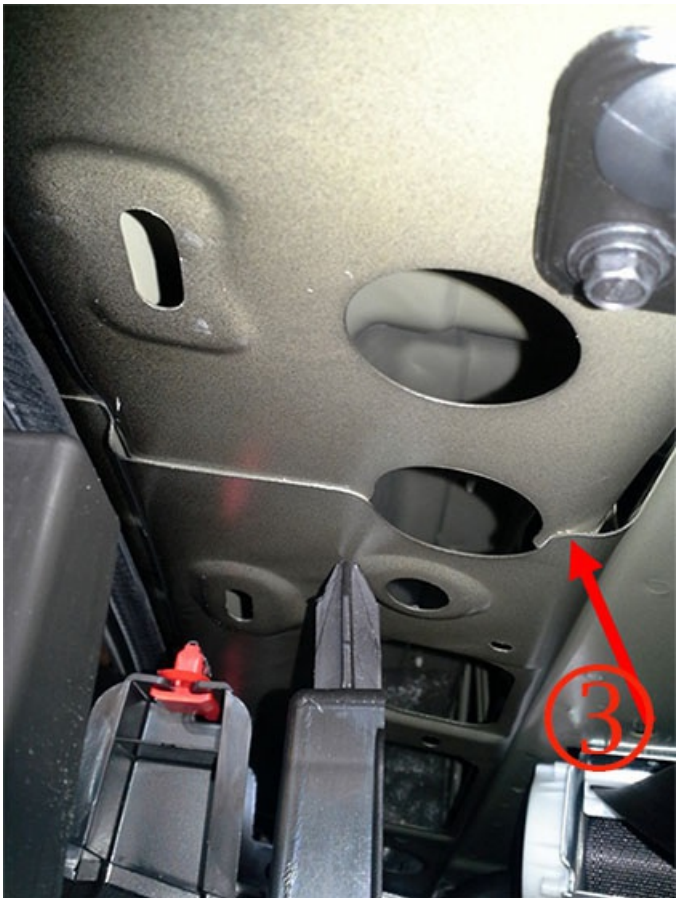
Using a screwdriver or other suitable tool slightly separate the sheet metal to eliminate contact between panels. Ensure that the tool is insulated so that it will not damage the finish.
Condition 3: Inspect C pillar for contact between sheet metal in area shown.

Using a screwdriver or other suitable tool slightly separate the sheet metal panels to eliminate contact.
