Preliminary Information

PIC6300 Various Noise Concerns Coming From the Folding Top Assembly

Brand:	Model:	Model Years:	VIN:		Engine:	Transmissions:
			from	to		
Chevrolet	Camaro	2016 - 2017	All	All	All	All
Involved Region or Country	All					
Additional Options (RPO)	CM8 - Convertible Top					
Condition	Some customers may have a concern where they hear a noise or various noises coming from the folding top assembly. These noises may be difficult for the servicing technician to isolate.					
Cause	This PI will provide 5 common locations for the dealership technicians to inspect for noises specific to the convertible.

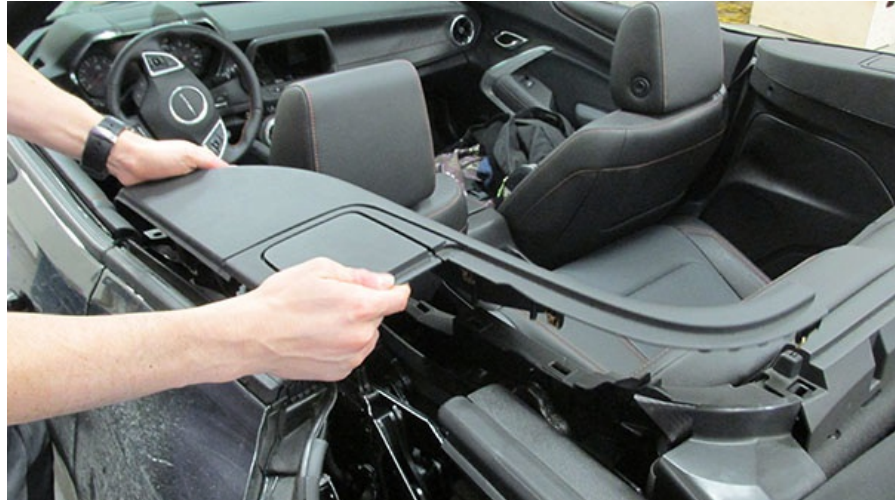
Flipper Door / Upper Quarter Trim Panel Area

This may described as a squeak, creak, or buzz type noise coming from behind the driver's head in the rear window area. This may be caused by the "flipper door(s)" rattling when the folding top is "up" or in the "closed" position. To confirm this noise is coming from the flipper door(s), either remove the trim panel as seen in the photo below, or simply open the folding top. These panels are referred to as the Quarter Upper Trim Panels in the Electronic Parts Catalog.

If the noise is narrowed down to the "flipper doors", replace the entire trim panel.

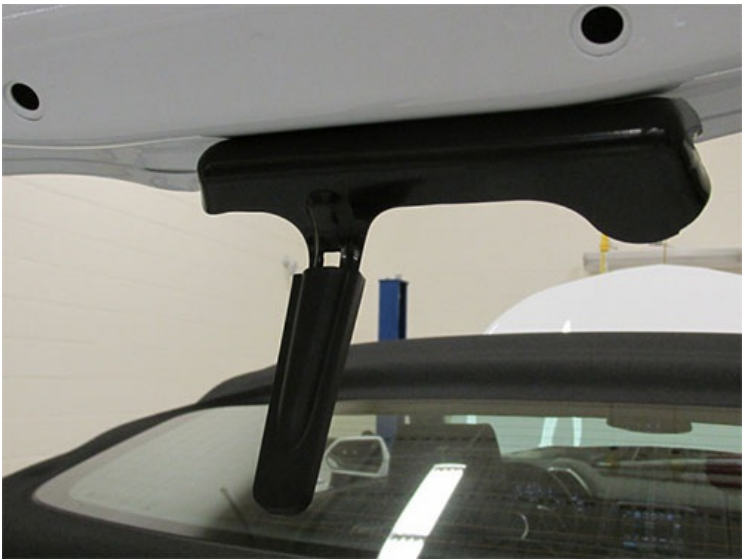
Some customers may comment on a buzz, snap, or rattle noise coming from the center of the tonneau cover area. There may be multiple issues, any of which may cause a similar noise. Be sure to inspect / diagnose all possibilities before assuming that only one issue is causing the customer's concern.

- One area of concern may be the plastic wedge cover that is installed on the center alignment pin of the tonneau cover. This plastic cover may slide or wiggle around, causing this noise. There were 2 styles of wedge covers used on these cars. The first style was a V-shaped plastic wedge cover as seen in the photo below. The second style was a modified V-shaped wedge cover. This second style had 2 flat areas at the top of the "V" that were actually parallel to each other. The first step in this repair is to replace the first style wedge cover with a second style cover. Then, as a second step, before the new plastic wedge cover is actually installed onto the metal post, wrap the post with 1 layer of flocking tape and then install the wedge cover over the tape. This will take up the slight gap and prevent this piece from rattling in the future.

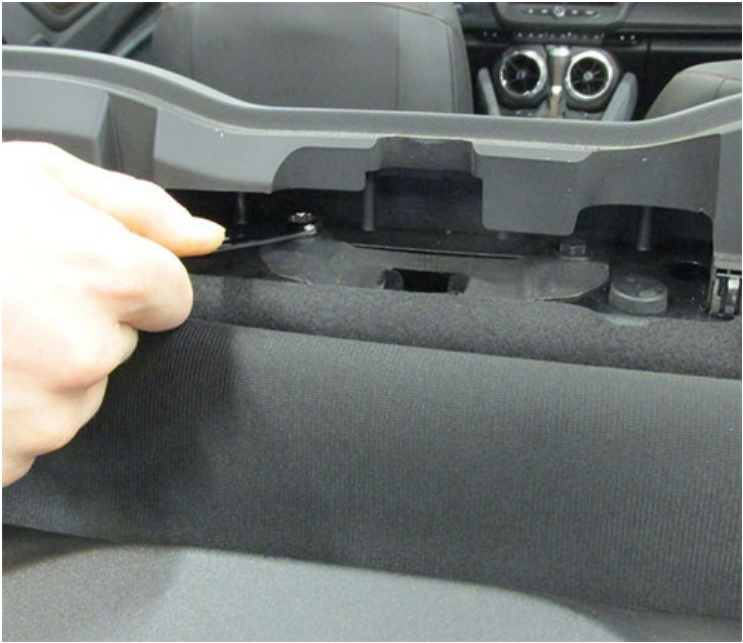
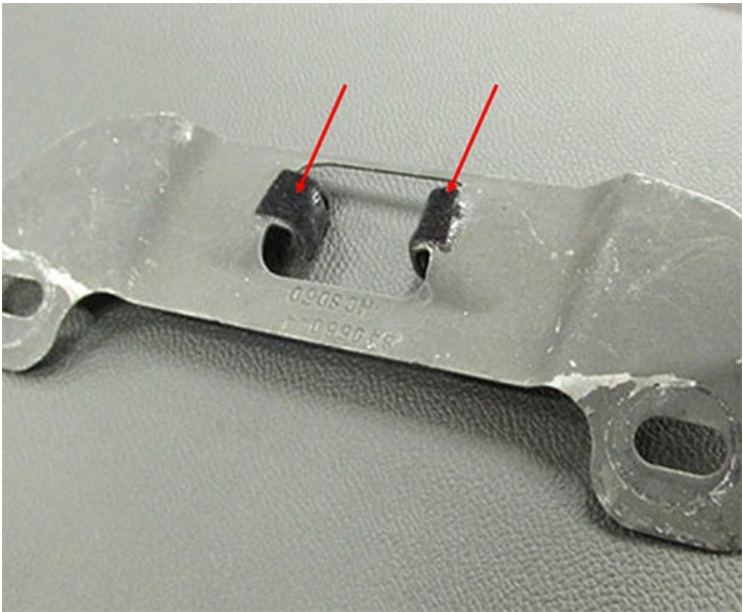
- The second area of concern may be the metal receiver that the alignment pin slides into. Remove the receiver from the vehicle, as seen in the photo below, and place it on a flat work surface.

NOTE: There is no need to completely remove the trim panel from the car in order to remove this metal receiver. Simply pop the trim panel up to release the clips. Then allow it to rest on the rear seat frame. This will allow enough room to remove the two fasteners from the receiver. If any flocking tape is found on the "ears" of the receiver, as indicated by the 2 red arrows in the second photo below, remove the tape and clean any residual glue from these "ears".

Before this receiver is reinstalled into the car, slightly bend the "ears" of the receiver as needed, so that the plastic wedge cover fits into the receiver without any looseness. It is VERY important that the wedge does not bind at all in the receiver, so make sure it is not too tight.

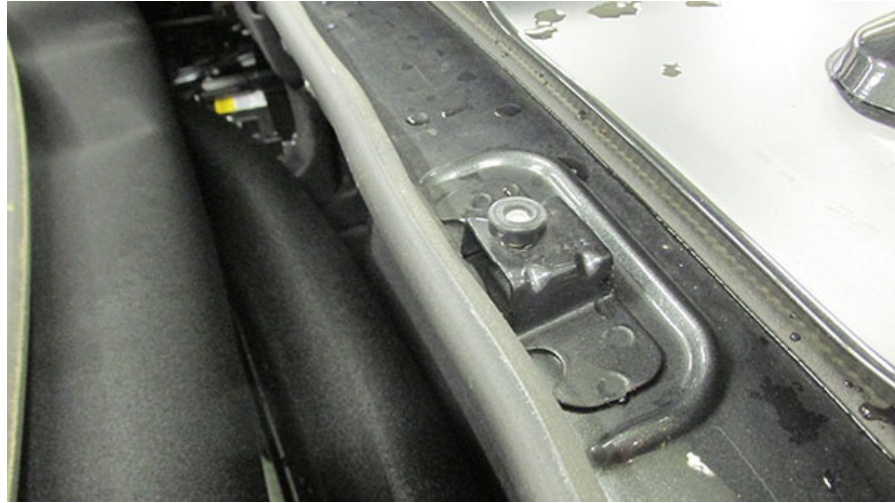
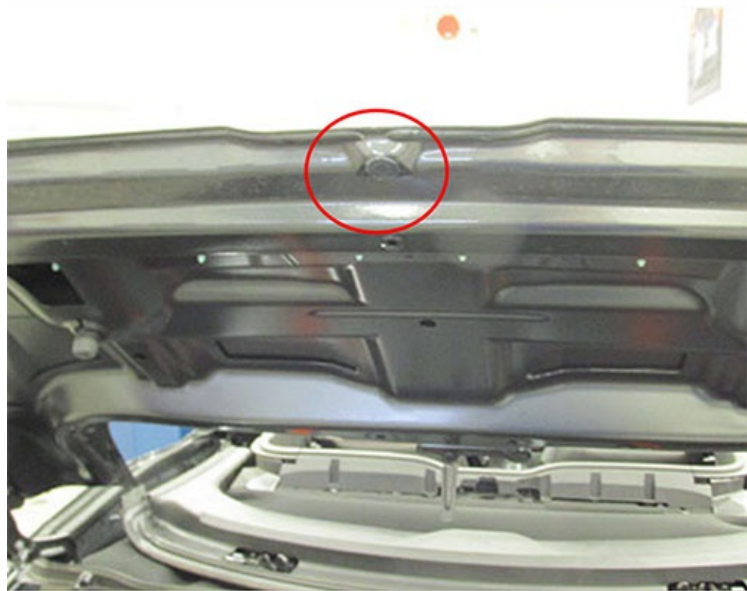
Ticking Noise From The Tonneau Cover

Some customers may comment on a noise coming from the center of the tonneau cover area that concern #3 does not address. This may be caused by the contact between the tonneau cover center bump stop as seen in the first photo below, and the tonneau cover itself. If this contact is causing a noise, apply a mylar patch (PN 84263959) to the body where this contact occurs. See the second picture below for the location of this patch.

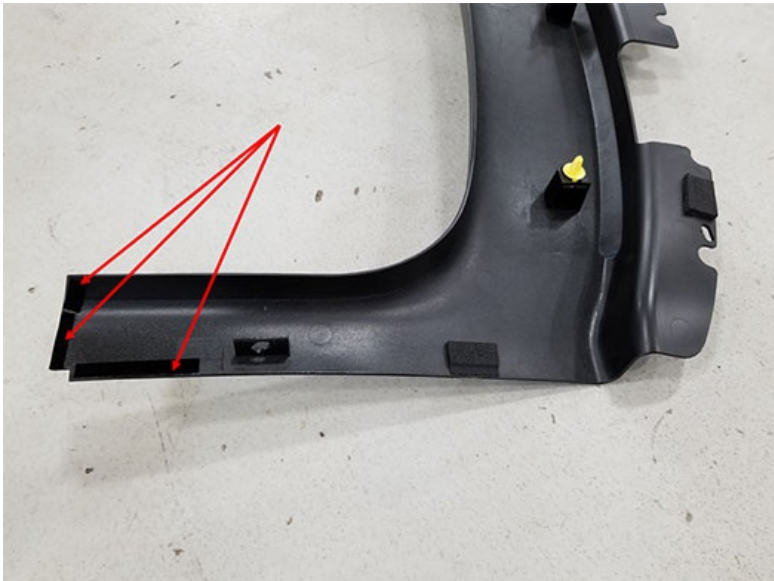
Noise From The Number 1 Bow (Header) Area

A noise may be heard from the header bow area of the folding top. Dealership technicians are to remove the trim panel from the underside of the 1 bow. Depending on the build date, there may or may not be retaining screws holding this trim panel in the car. Once the panel has been removed, technicians are to first inspect for the presence of yellow push pins on the underside of the panel. If all of the push pins on the underside of this panel are black in color, replace them with new clips. The new, updated clips are yellow in color. Next, verify that both flocking tape and foam blocks can be found around the perimeter of this trim panel. The flocking tape should be located on the trailing edge of the panel and must be orientated as seen in the photo below.
