# Preliminary Information

## PIP5163C Alleged Cylinders Out Of Round

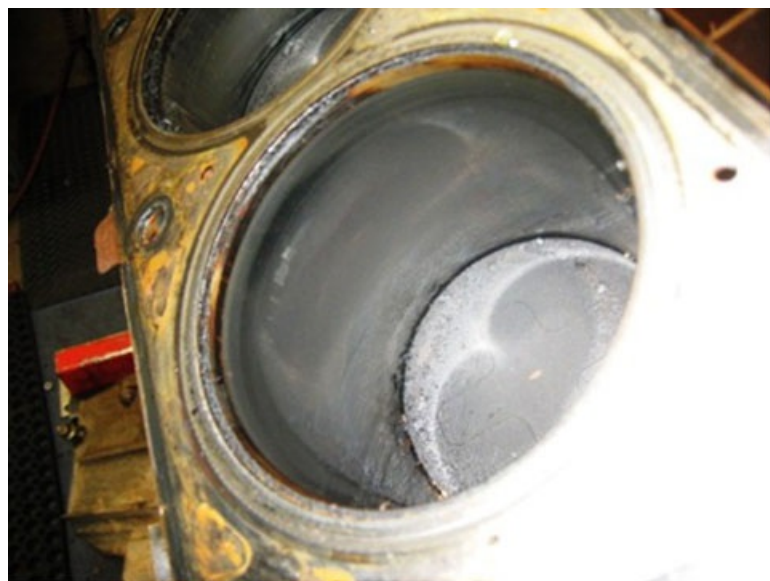
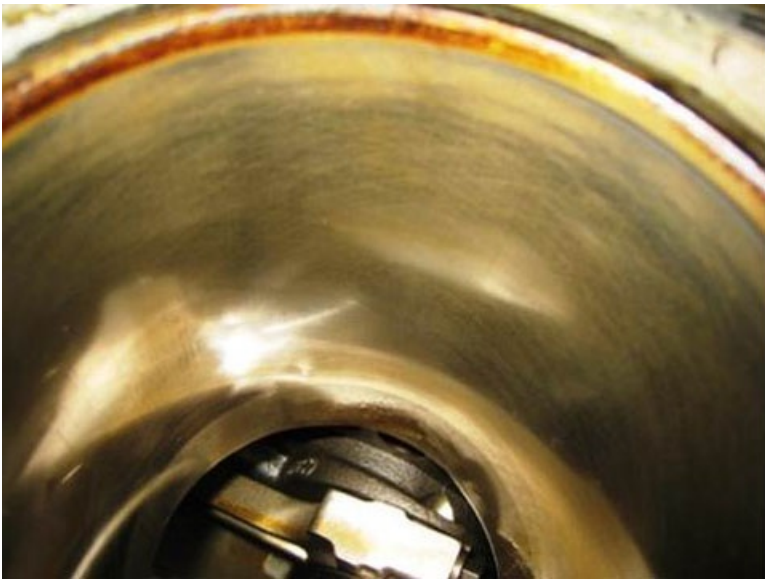
1. Cylinder damage or scoring- the cylinder walls will contain grooves deep enough to catch with a finger nail.
2. An out of round cylinder bore- will contain areas where the cross hatch is missing or worn from different section of the cylinder bore. If there is crosshatch all the way around the bore from top to bottom the cylinder bore is not out of round.

3. Dirt intrusion- If the filtering system has been compromised the engine will wear out very quickly. You will find grit in the intake Runners and the cylinder bores will look lightly sand blasted. The crosshatch will be faint and there will not be sharpness. At high mileage this Should be an insurance claim if the air filtering system has been opened numerous times for service in dusty climates.

4. Catalytic Converter failure- If a converter fails and the brick is broken, the dust can be drawn back into the engine. A block showing this type of failure, will have bores that look to be sand blasted. Back cylinders go first if caught early. Otherwise there will be no Crosshatch and the engine will need to be replaced.
