PIP5421D Malfunction Indicator Lamp Illuminated With DTC P0300

Brand:	Model:	Model Years:	VIN:		Engine:	Transmissions:
			from	to		
Chevrolet	Malibu	2016 - 2017	All	All	1.5L LFV	All
Involved Region or Country		USA, Canada				
Additional RPOs:		LFV				
Condition		Some customers may comment on a rough running engine with the Malfunction Indicator Lamp on. Upon inspection, a technician may find DTC P0300 set along with a misfire and low compression in one or more cylinders.				
Cause		This condition may be caused by a damaged piston requiring replacement of all four piston and rod assemblies with an updated part number.

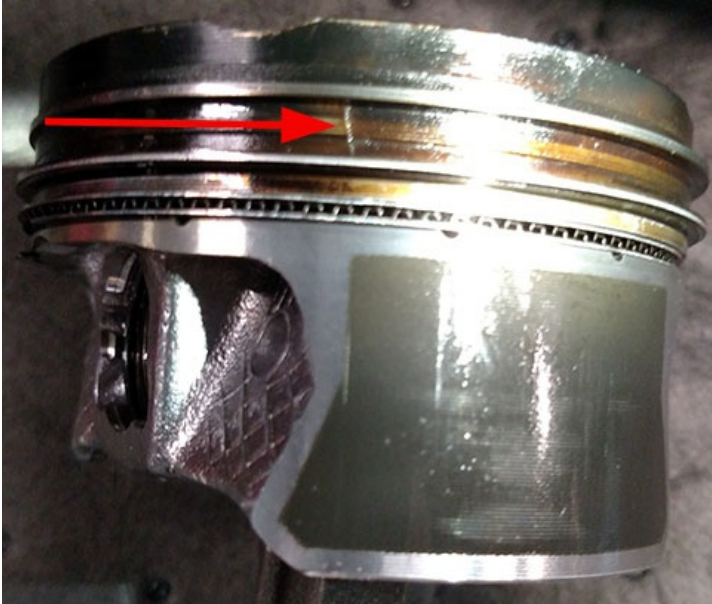
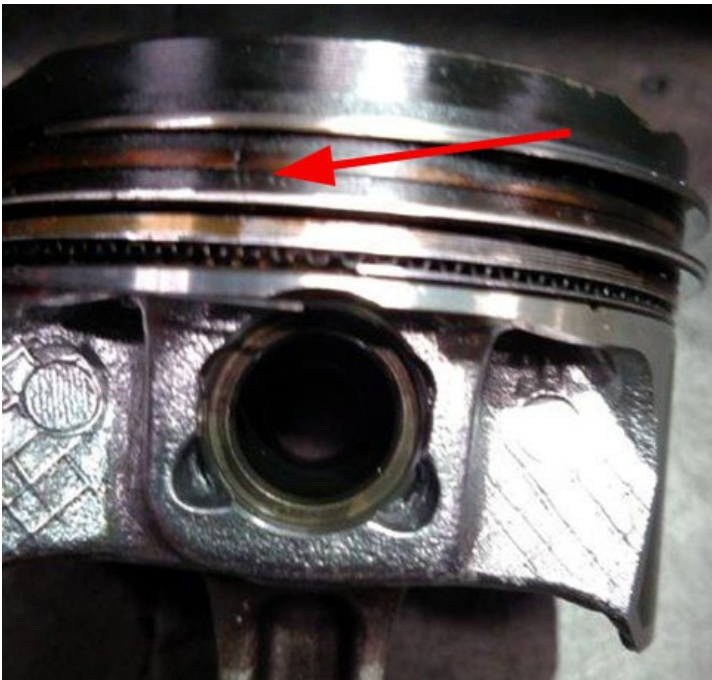
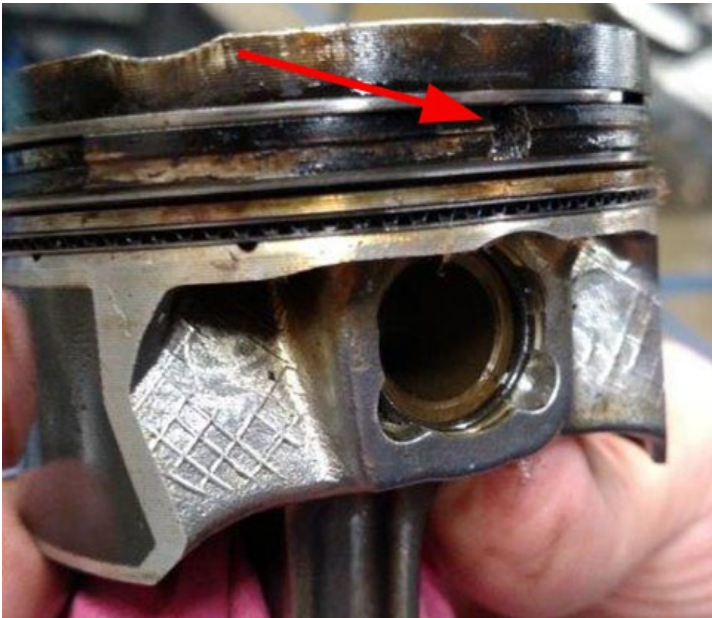
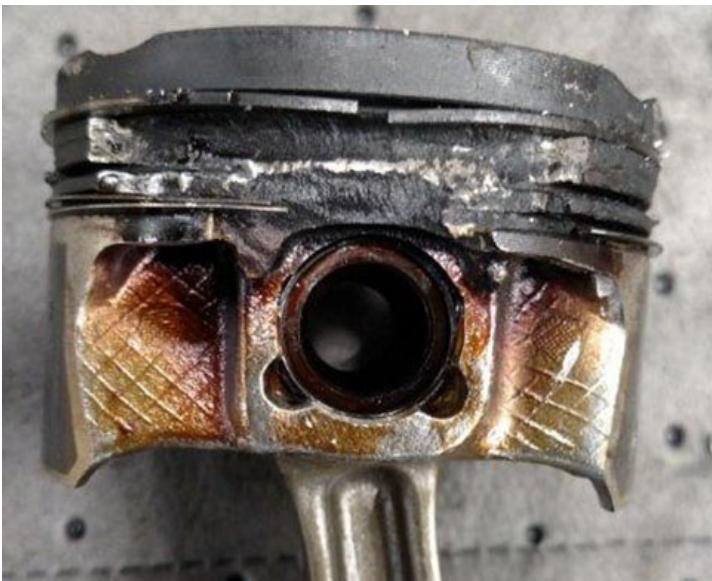
Shown below are examples of pistons with varying levels of damage.

If the cylinder wall surface has not been compromised, replace all four piston and rod assemblies.

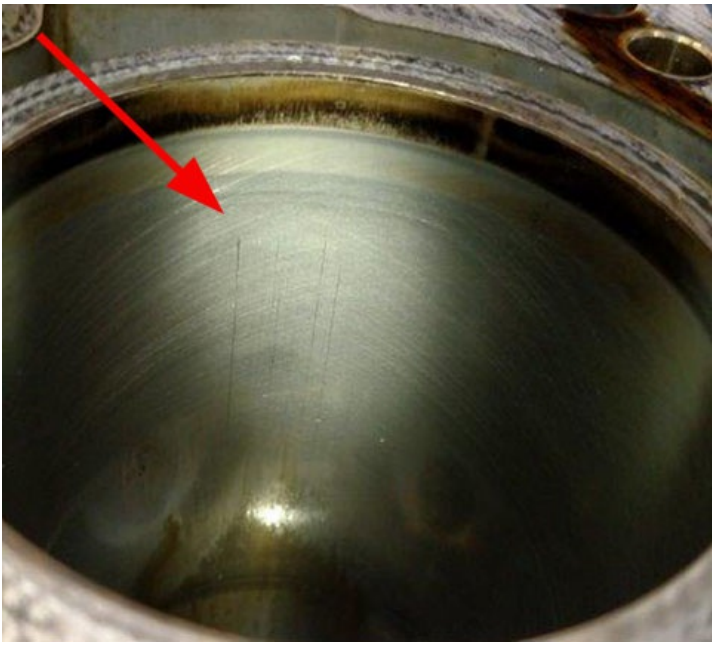
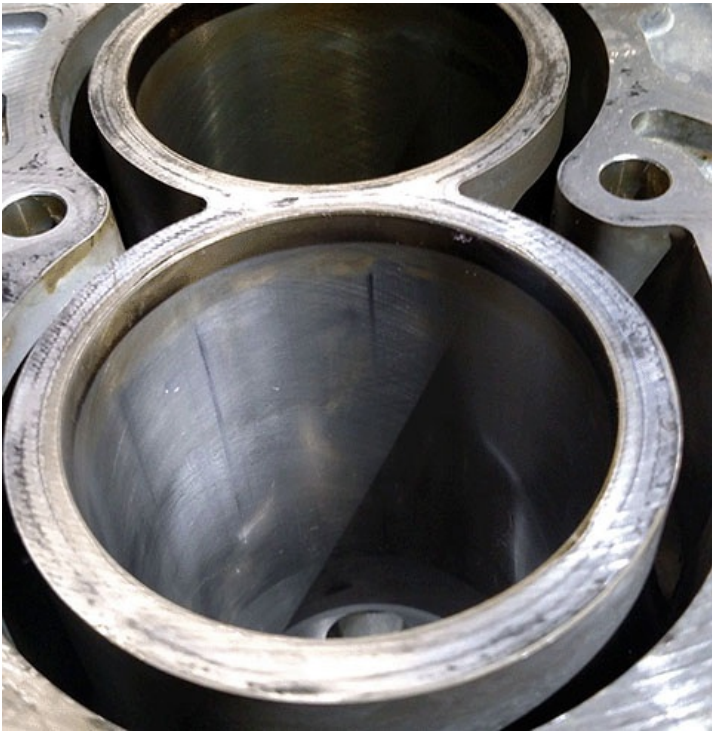
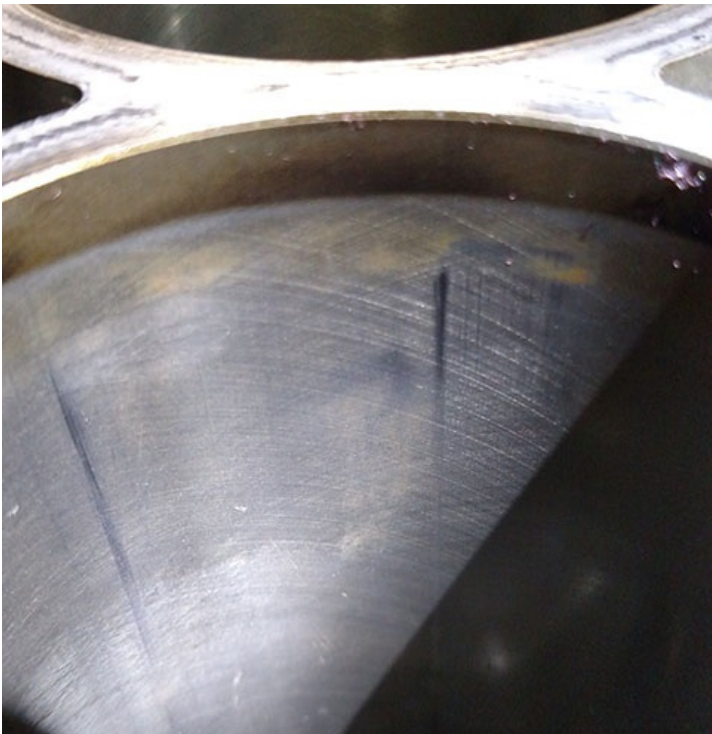
Shown below are several examples of light vertical marks visible on the cylinder wall.
In these examples, none of the marks in the cylinder walls could be felt with the finger tip or nail and engine replacement is not recommended.
