Preliminary Information

PIP5335A SES Lamp With Camshaft Position Codes P0340 and/or P0341

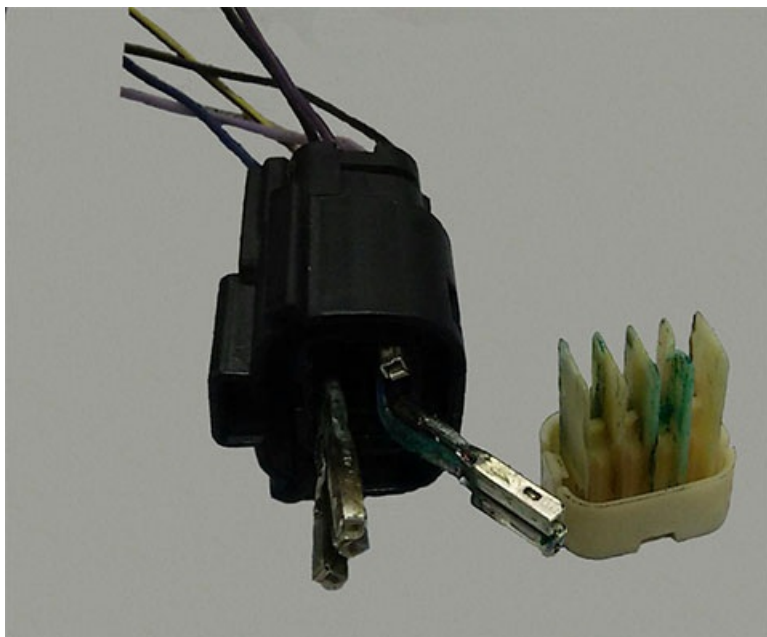
If normal SI Diagnostics does not isolate the concern, inspect for corrosion in connector X154 located on the front cover next to the vacuum pump.

See the illustration below

If this condition is encountered repair as needed.
