Preliminary Information

PIP4959F Cold Start Misfires

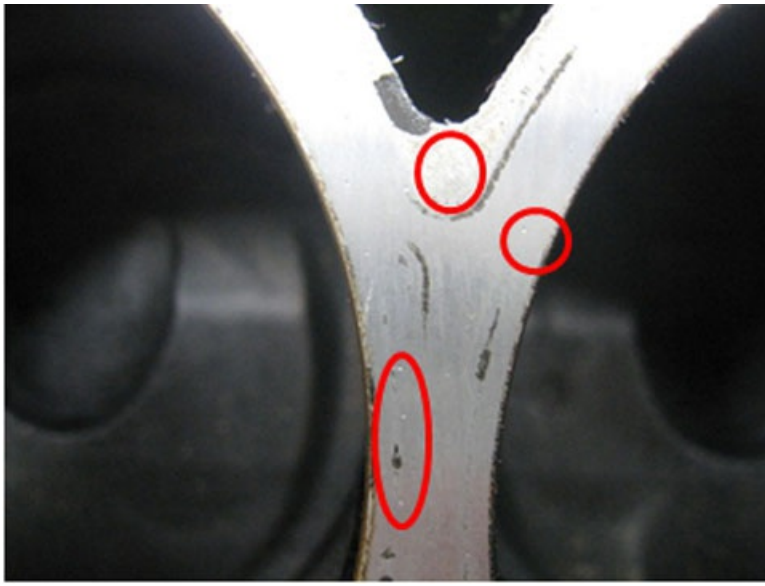
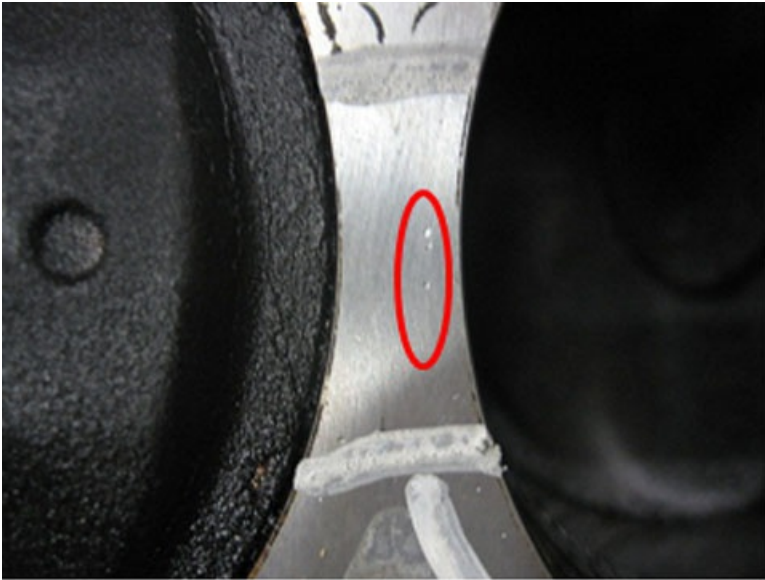
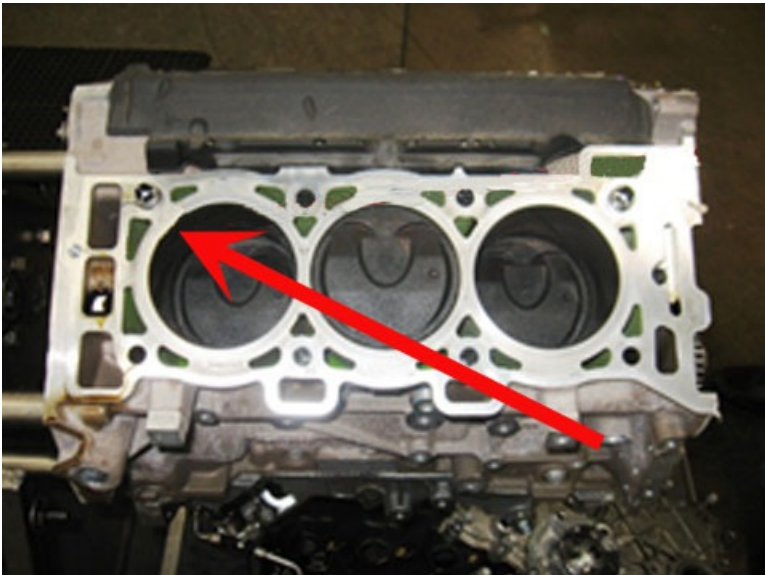
See pictures below for examples of deck pitting and actual porosity with leak path.

Small surface pock marks or pitting appearance on the deck surface is normal and engines should not be replaced for such appearance as they do not connect to coolant passages and cause a leak path that generate engine misfires.

During engine warranty analysis studies, engines are being replaced for small pitting in the deck face as described above, when the subject cylinder / piston is saturated with fuel and not coolant.

Engine replaced for subject pitting conditions will be returned to the dealership as non defective.

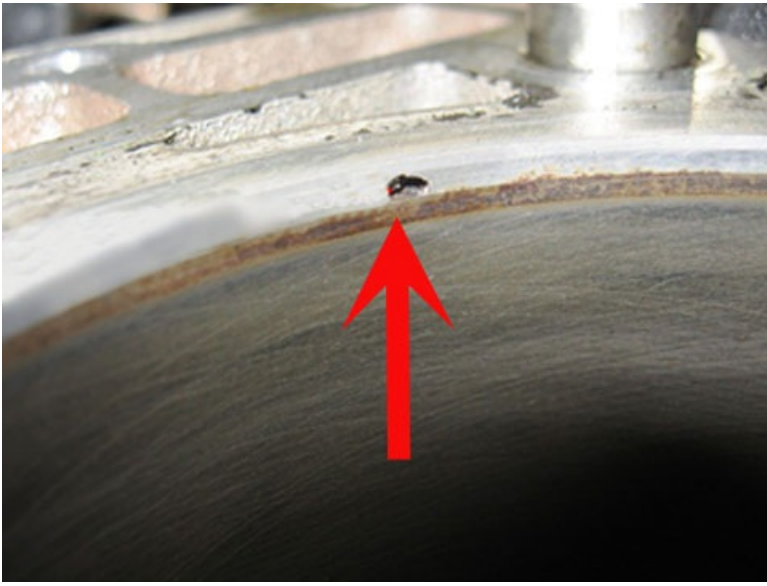
Location: # 5 at the 10:00 o'clock position.

The photo above is an example of what true porosity is.

Cylinder deck face to cylinder liner interface location can cause a leak path into the cylinder for rapid large counts of misfires when cold.

Such Porosity is rare, therefore technicians should inspect the subject cylinder and look for a break in the carbon ring.

Usually if porosity is present there will be a break in the carbon ring.

Coolant present in a cylinder cleans the area of entry and can be found by wiping the carbon ring dry with a clean soft towel, exposing the leak path. Only if true porosity is found would engine replacement become necessary.

Call PQC per the latest version of [16-NA-338](#), if required, reference this PI and replace the engine, ONLY in cases where porosity has been found to be the cause.
