Preliminary Information

PIP5468C Check Engine Light On with Leaks in the Charge Air Cooler System.

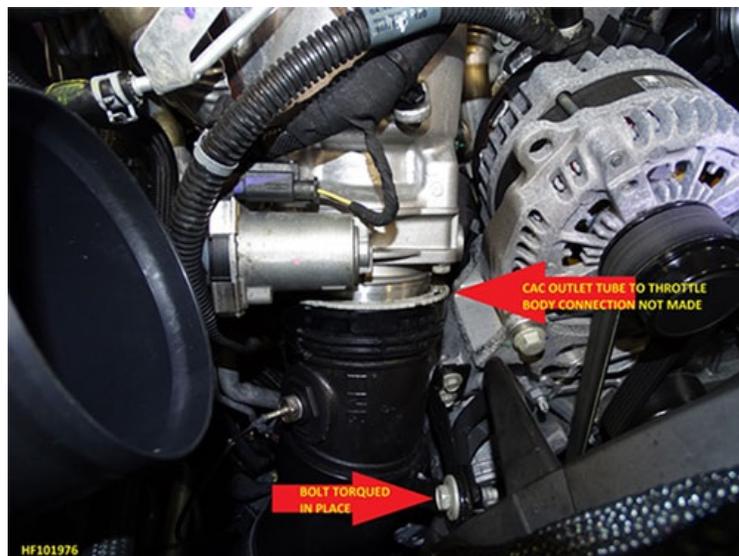
Check for non-secured connection of the charged air cooler pipe at the intake air flow valve (throttle body).
Check for proper alignment of the charged air cooler pipe bracket and bolt hole.

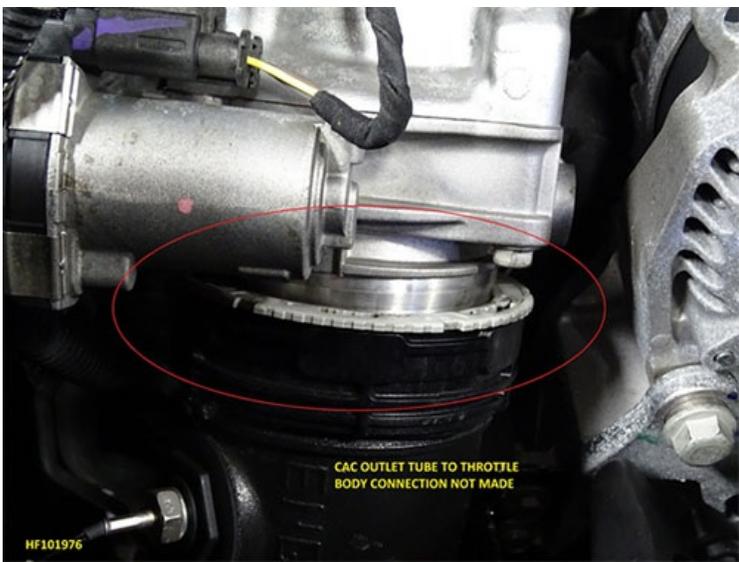
Non-secured connection.

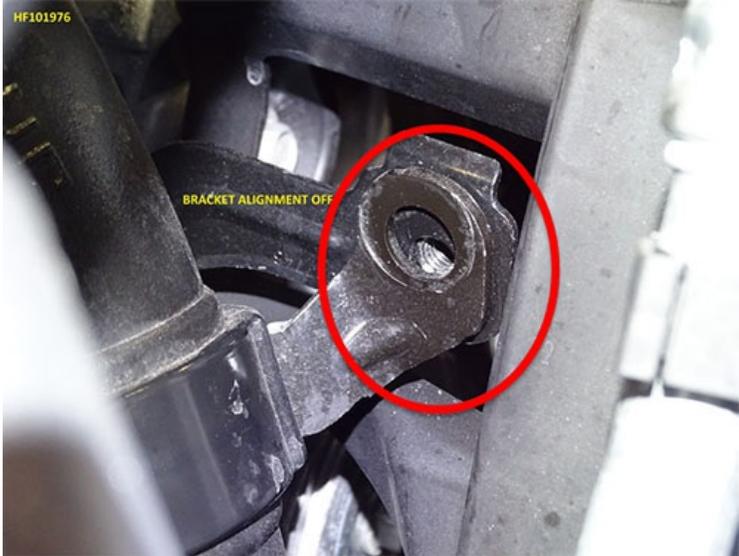
Mis-aligned charged air cooler pipe bracket and bolt hole after the charge air cooler outlet hose is connected properly to the throttle body.
