Preliminary Information

PIT5584 Rear Tailgate Fitment Issues On Trucks With High Desert Package

Models

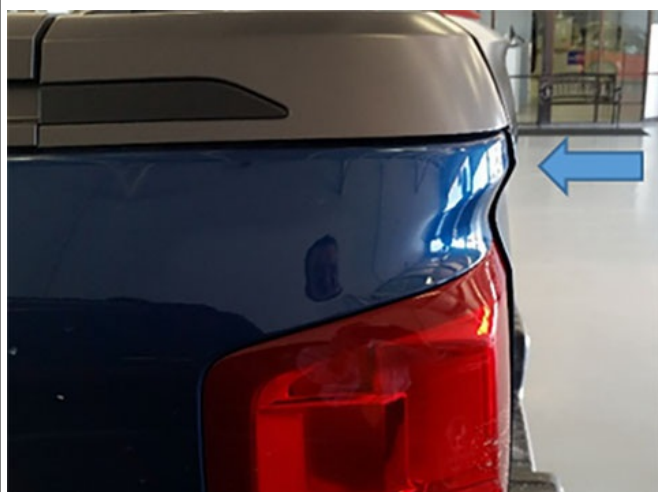
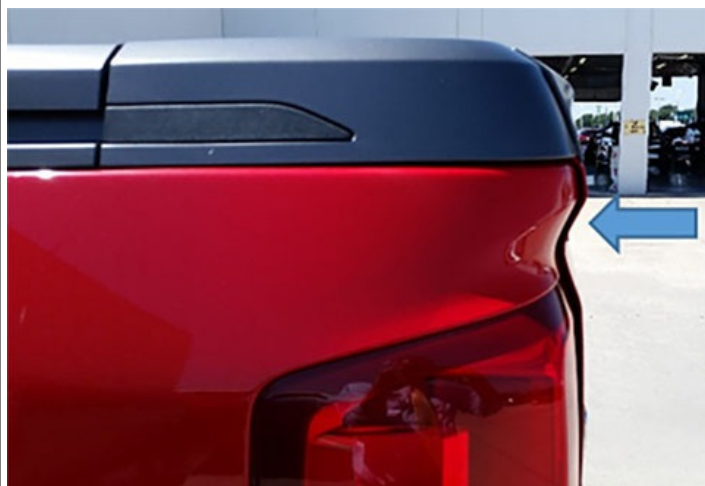
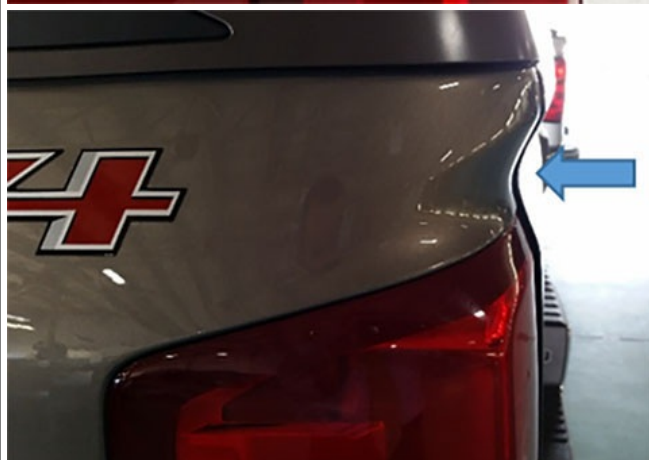
Condition

For vehicles with the High Desert Package (RPO ZYD). Some customers may comment on the tailgate fit, generally on the driver's side. The tailgate may protrude out from the quart panel. If standard tailgate adjustments do not bring the tailgate in spec (Flush +/- 1.5mm), proceed with the recommendations below.

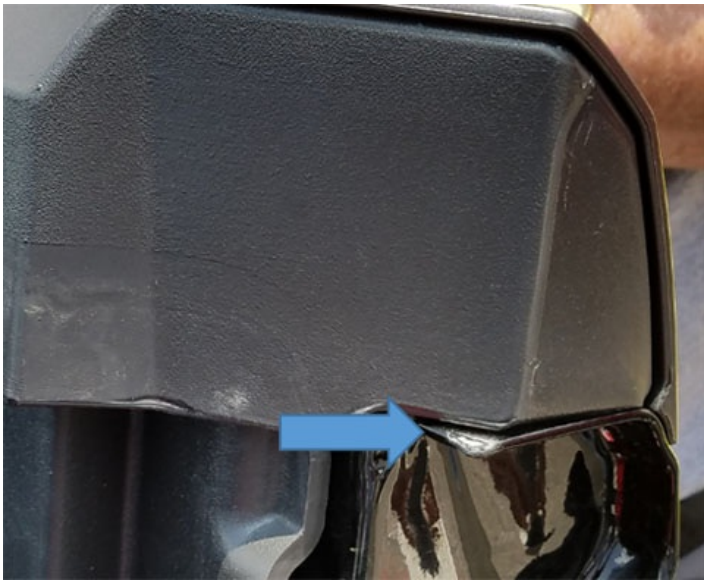
Before proceeding with this repair, it should be determined that the tailgate is coming in contact with the High Desert Package which is not allowing the tailgate to be flush.

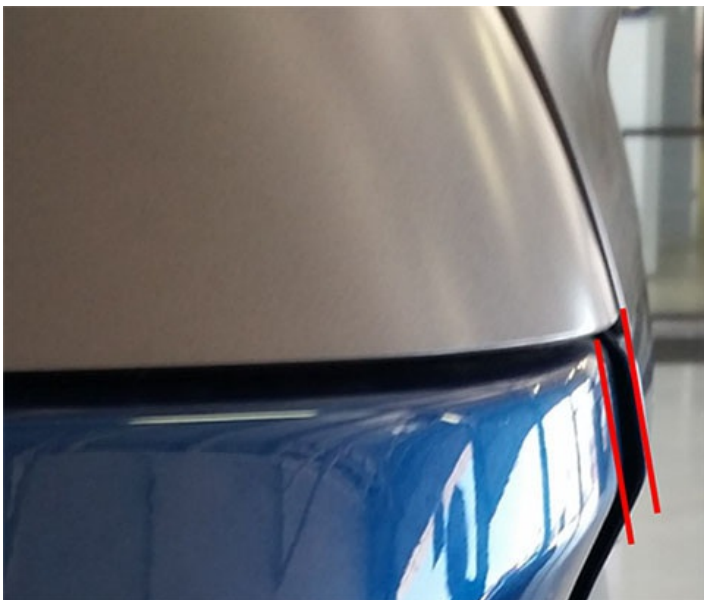
In many cases, a witness mark can be seen on the tailgate showing the contact.

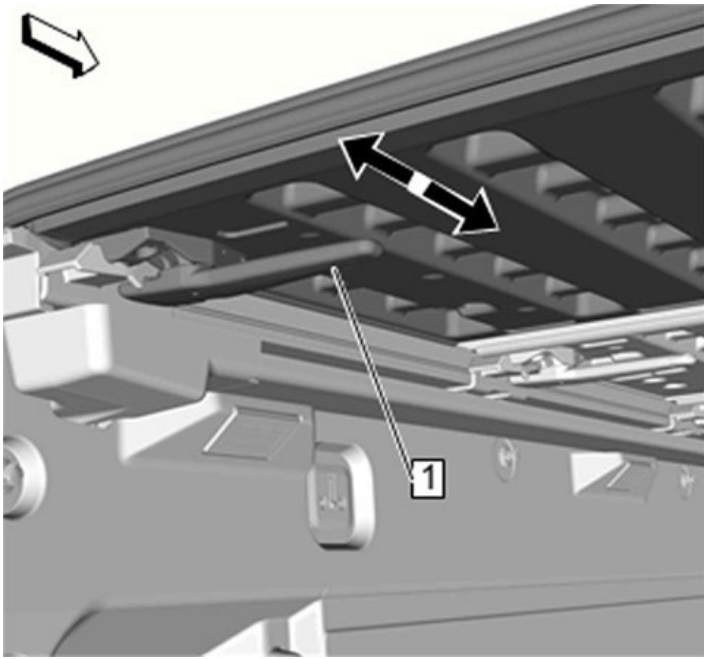
Additionally, the High Desert Trim may not sit flush with the Tailgate/quarter panel.
