Preliminary Information

PIP5321E Volt 5ET50 Transmission Component Restriction Program

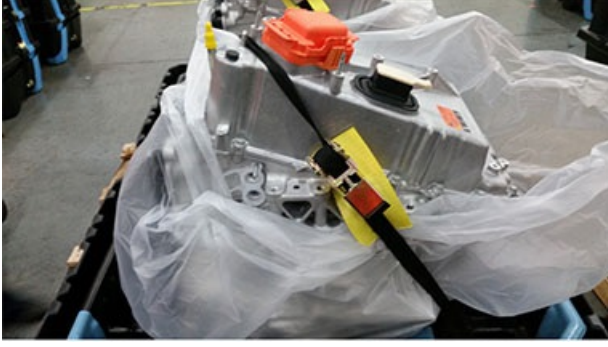
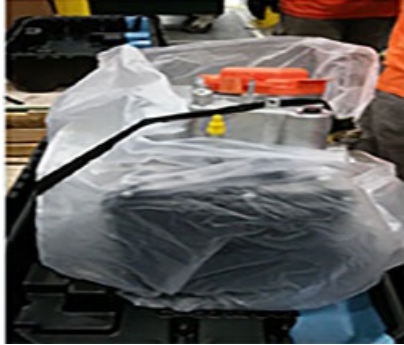
Please make sure that you are strapping the transmission down. Most of the transmissions are being returned have sustained damage

from shipping.

Position the strap as shown in the pictures below and tighten with the ratchet.
