Preliminary Information

PIP5489A DTC P0106 Caused By Snow or Water Intrusion Into The Air Cleaner

Models

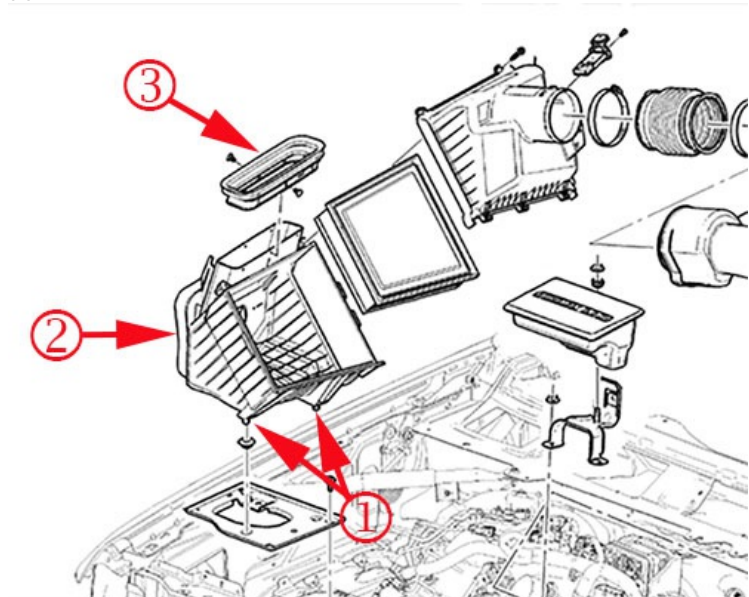
Confirm that the air filter box is in position, securely retained to the air cleaner bracket (1), that it is sealed to the inner fender (2) and to the hood (3).

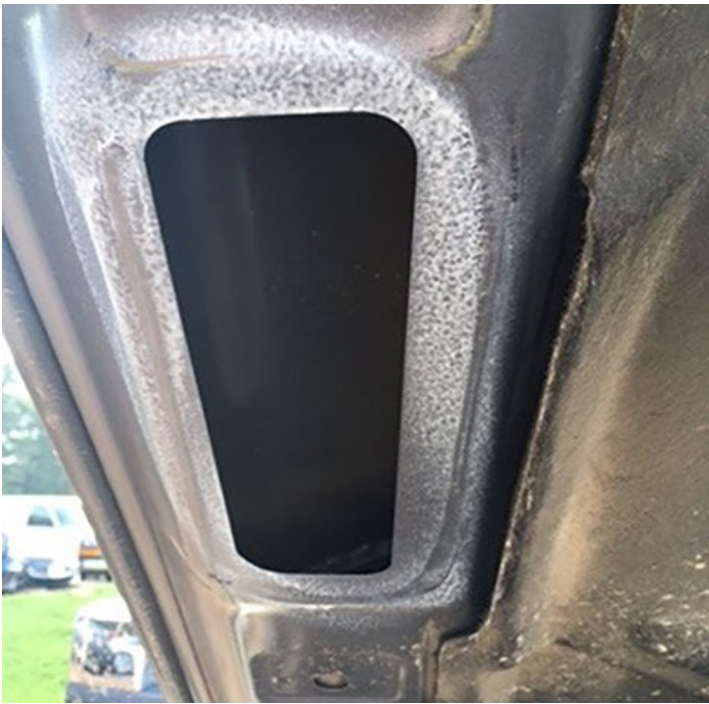
Proper sealing between the air box upper gasket (3) and hood can be checked by wetting the gasket (foaming glass cleaner was used in the photos below), closing the hood and then checking for a contact ring witness mark around the entire hood duct opening to the air cleaner assembly.

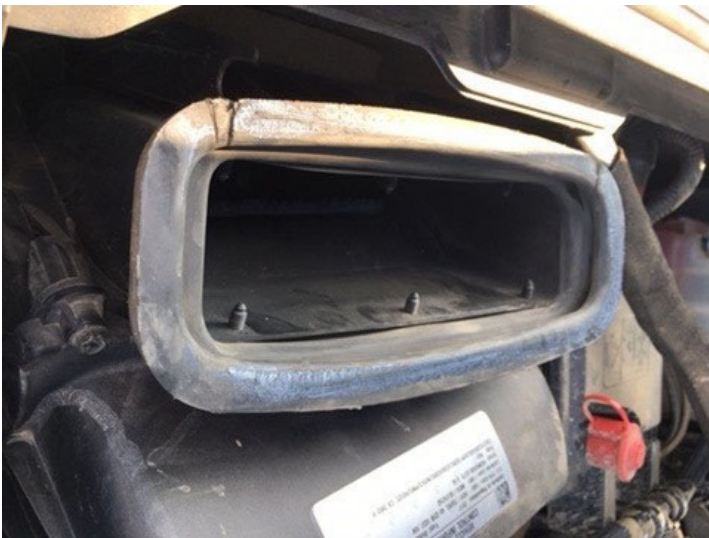
The photo below shows a lack of contact in the front edge of the air cleaner seal.

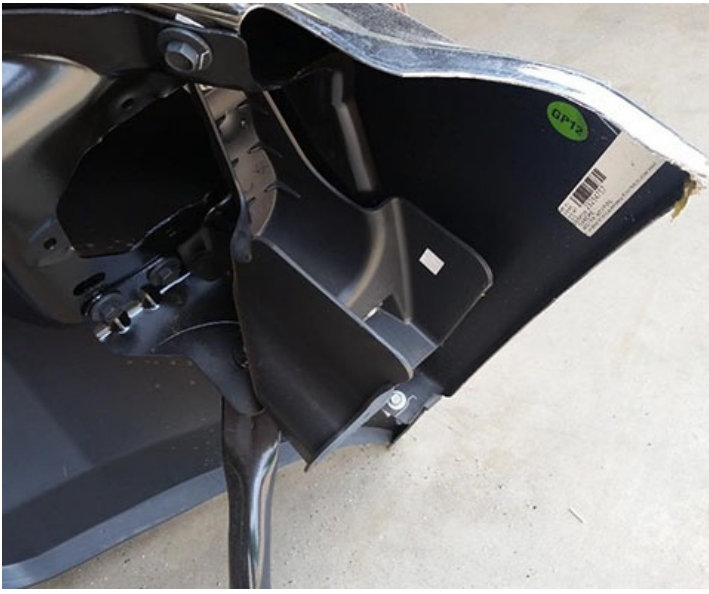
Aftermarket Bumper Installed

OEM bumper with intake air box protection to help prevent moisture and other debris getting into the air cleaner box.

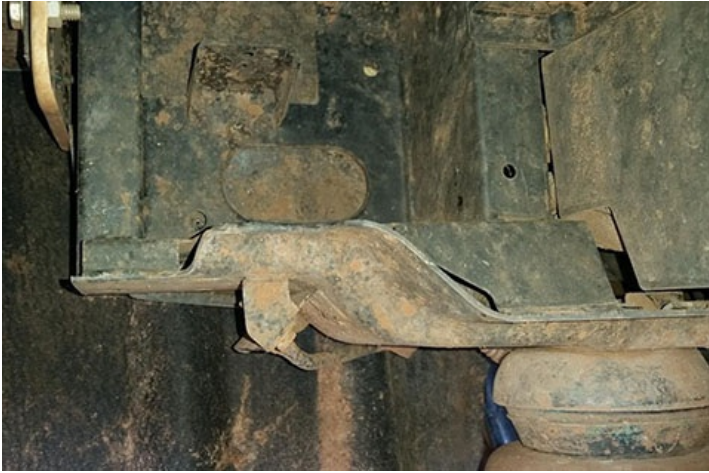
Aftermarket bumper without intake air box protection.
