Service Bulletin

Subject: Vibration Analysis Diagnostic Aids

Brand:	Model:	Model Year:		VIN:		Engine:	Transmission:
		from	to	from	to		
Cadillac	Escalade Models	2015	2017				
Chevrolet	Suburban						
	Tahoe						
GMC	Yukon Models

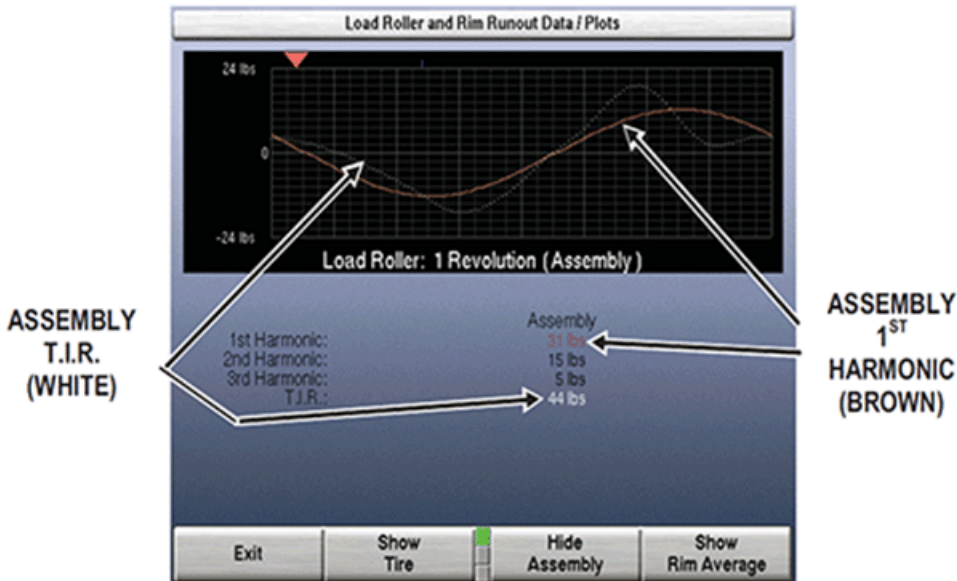
- Some cases of tire/wheel assemblies have been shown to have acceptable T1 RFV numbers, but with further investigation, have been found to have bent inboard rim flanges with hidden tire damage, visible inside the tire sidewall when dismounted.

- The Hunter 9700 checks tire low-speed RFV only, in the radial plane only.
 - ⇒ The Hunter 9700 is set to display T1 RFV as the default.

Higher order RFV, T2 & T3 can be displayed in the Assembly Data Plots Screen, as shown above. Depending on the level of 9700, the screen may be under 'Data' or 'Runout Plots,' then "Rim and Load Roller Runout Plots," or 'Road Force', 'Force Match', 'Data and Plots', 'Show Details.'

- Engineering analysis of 2nd order tire issues, especially as they relate to 22-in tires, has determined that tire bead to rim seating is a critical component. To address a T2 issue, deflate the tire and perform bead massaging on the tire changer, then re-inflate the tire and check on the 9700. Ensure correct tire lube is used and that the lid is kept closed to preserve chemical integrity – if the lid is left open, the drying agent will be lost, promoting tire slip. Refer to 12-03-10-001: Vibration Shortly After Tires are Mounted/Preventing Vibration from Wheel Slip (Tire Sliding on Wheel) for information on Bead Seating.

- When checking tires on the 9700, if (radial) T2 is high or close to the (radial) T1 value, the tire should be worked focusing on tire bead seating, then if necessary the Hunter 180 Match Mount Process should be utilized before tire replacement, as mentioned below.

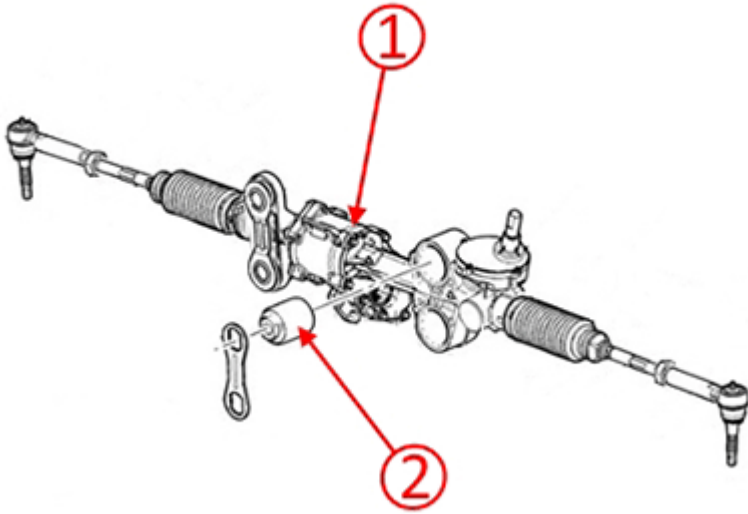
Steering Gear/Rack Bushing Replacement

A revised steering gear/rack (1) mounting bushing (2) has been released to address customer vibration concerns. After various testing and measurement of T1 vibration, a vibration path from the tie rods =>steering rack=>steering bushings=>frame=>body mounts=>cabin floor=>seats has been identified. To help isolate the steering rack, a revised hydraulic mounting bushing has been released and tuned for the T1 frequency. The new steering rack bushing dampens minor T1 vibrations. It has been found that the new bushing also helps dampen minor T2 vibration / disturbance. This is the reason that the causal part (normally the Tire/Wheel Assembly) must be corrected first. If T1 vibration is over 20-25m/g's, the bushings will have little to no effect. Likewise, for T2 vibration / disturbance, the causal part/area must be corrected first to benefit from the bushings.

For vehicles with T1 vibrations under 20-25m/g's, replace steering rack bushings per parts catalogue. Refer to Steering Gear Mount Bushing Replacement in SI.

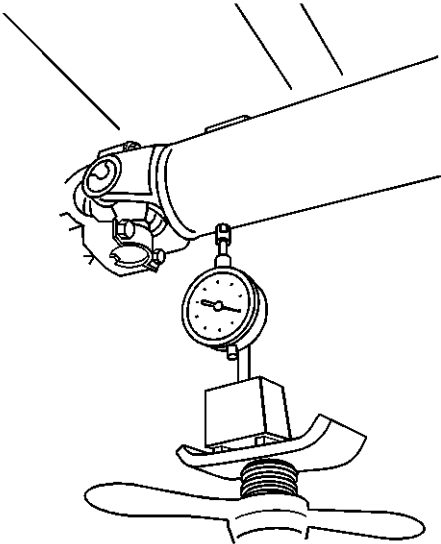
1. Inspect the propeller shaft for dents, damage, and missing weights. There have been many cases of dented propeller shafts. Damaged prop shafts must be replaced.

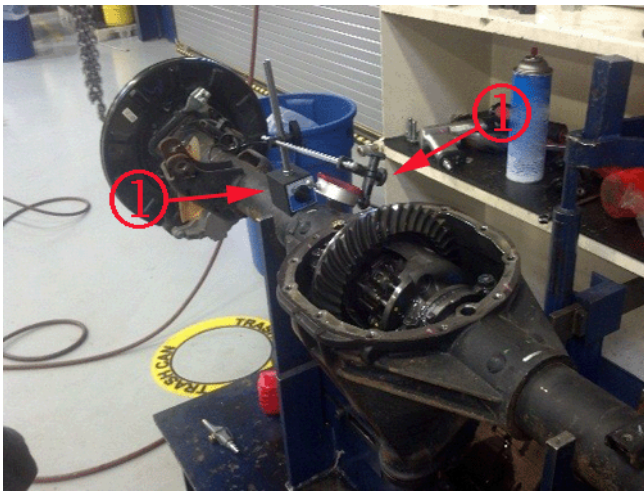
Backlash Adjustment Procedure

Note: The illustration above is for reference only. The axle does NOT need to be removed from the vehicle.

1. Perform the Backlash Adjustment procedure, with the following Exception: *Each Tooth* of the ring gear *Must* be measured. The SI procedure mentions 8-points; however to ensure a possible vibration disturbance point is identified, *Each Tooth Must* be measured. Refer to Backlash Adjustment, SI Document ID # 3269088.
2. The above picture is included to help clarify setup of the dial indicator for measurement.
3. Once the backlash and bearing preload is correct, perform a gear tooth contact pattern check in order to ensure proper alignment between the ring and pinion gears. Refer to the Gear Tooth Contact Pattern Inspection in SI, Document ID # 1990157.

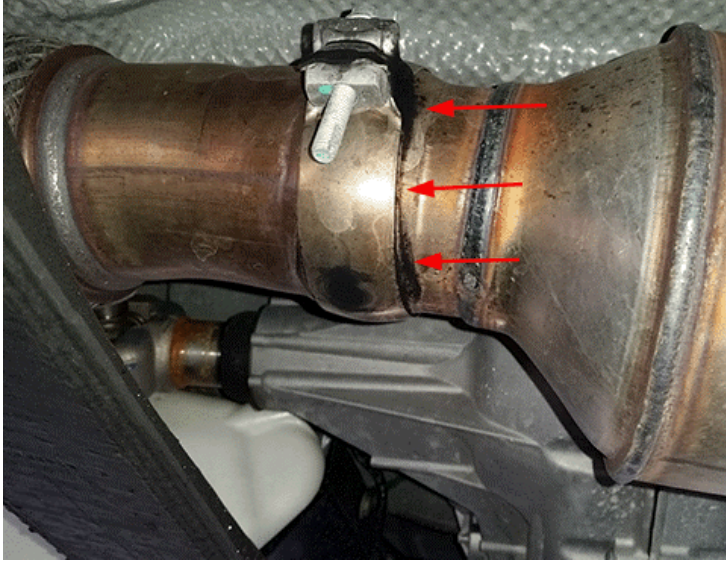
Note: There have been some cases of excessive V4 drone on 5.3L SUVs with the updated exhaust – a leak at the exhaust Norma clamp joint behind the rear converter may allow E2 V4 drone to manifest. 6.2L engines with a leak at the same exhaust clamp joint may allow excessive drone – more than comparable vehicles. Refer to latest version of PIP5442.

If Pico readings line up as specified, refer to PIT5404 for specific V4 Mode Exhaust Drone diagnostic information.
