Service Bulletin

Subject: 17-H-011 — Deck-lid anti-flutter mastic separation (Service deck-lids only)

Make:	Model:	Model Year:		VIN:		Engine:	Transmission:
		from	to	from	to		
Holden	VF Commodore	2014	2015	NA	NA	NA	NA

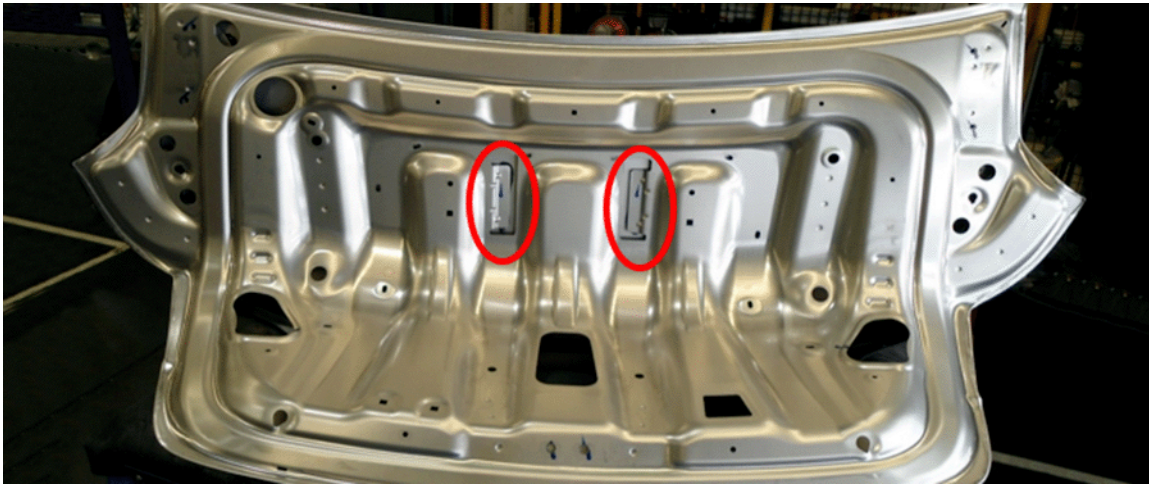
Figure 1 – Deck-lid inner with trim carpet removed showing the two inner panel tabs

1. With the decklid trim carpet removed it should be possible to observe the two inner panel tabs as highlighted in Figure 1. If separation of the anti-flutter mastic exists between these tabs, then proceed with the rework procedure.

Note: If reworking a decklid that is not fitted to a vehicle, ensure the decklid is placed on a clean table where the tabs are vertical as shown in Figure 1.
